Access Compliance Report Public Rights-of-Way (Curb Ramps)

Intersection ID: 13314 Main Street: BALGREEN_CT Cross Street: BIEDERBECK_DR Location: SE

ADA ID: DCBF4D72A82B Ramp Type: PerpDiag Initial Pass/Fail: Fail Overall Compliance: No Severity Score: 17.5

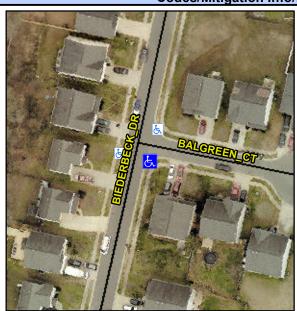
Not Found, R304.5.1

Field Measurements/Component Compilance					
Compliance Description		Data	Compliance Description		Data
N/A	Ramp Length (in)	49.0	Yes	Ramp Slope (%)	6.2
No	Ramp Width (in)	33.0	Yes	Ramp XSlope (%)	0.3
N/A	Flare Type LT	N/A	N/A	Flare Type RT	N/A
N/A	Flare Slope LT (%)	N/A	N/A	Flare Slope RT (%)	N/A
N/A	Flare Traversable LT?	N/A	N/A	Flare Traversable RT?	N/A
N/A	Landing Length (in)	N/A	N/A	DWS Provided?	N/A
N/A	Landing Width (in)	N/A	N/A	DWS Contrast?	N/A
N/A	Landing Slope (%)	N/A	N/A	DWS Length (in)	N/A
N/A	Landing X Slope (%)	N/A	N/A	DWS Full Width?	N/A
N/A	Landing Curb? (Y/N)	N/A	N/A	DWS Offset (in)	N/A
N/A	Shared Landing?	N/A			
N/A	Gutter Ponding?	N/A	N/A	Gutter Slope (%)	N/A
N/A	Gutter Lip Ht (in)	N/A	N/A	Gutter X Slope (%)	N/A
N/A	Painted X Walk1?	No	N/A	Painted X Walk2?	No
	X Walk 1 Direction	To NW		X Walk 2 Direction	To NE
N/A	X Walk 1 Width (in)	N/A	N/A	X Walk 2 Width (in)	N/A
	X Walk 1 Slope (%)	3.1		X Walk 2 Slope (%)	3.3

X Walk 1 X Slope (%)	2.7		X Walk 2 X Slope (%)	2.9
N/A	Ramp inside XWalk1?	N/A	N/A	Ramp inside XWalk2?	N/A
	Road Slope (%)	0.9	N/A	Clear Space?	N/A
	Road X Slope (%)	3.3	N/A	Clear Space to XWalk (in)	N/A
N/A	Any Obstructions?	N/A	N/A	Storm Grate/Utility Hazard?	N/A
	Obstruction Type			Storm Grate/Utility Type	
		N/A			N/A
			Yes	Surface Condition? (G/P)	Good

Remove & Replace Curb Ramp With
Two New Directional Ramps or
Equivalent.

Total Cost: \$ 3200.00
