Access Compliance Report

Public Rights-of-Way

(Curb Ramps)

Intersection ID: 47575	Main Street: GLENBURN_LN	Cross Street: GAILES_DR	Location: SW
ADA ID: DCCC54C791CD	Ramp Type: PerpDiag	Initial Pass/Fail: Fail	Overall Compliance: No
Severity Score: 37.5			
Codes/Mitigation Info/Possible Solution		Field Measurements/Component Compliance

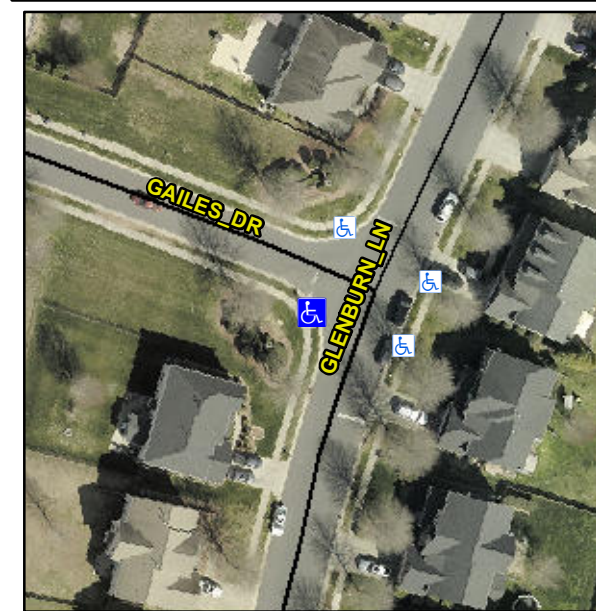
Not Found, R304.2.2, R304.5.3

Compliance	Description	Data	Compliance	Description	Data
N/A	Ramp Length (in)	45.0	No	Ramp Slope (%)	8.7
Yes	Ramp Width (in)	48.0	No	Ramp XSlope (%)	8.1
N/A	Flare Type LT	N/A	N/A	Flare Type RT	N/A
N/A	Flare Slope LT (%)	N/A	N/A	Flare Slope RT (%)	N/A
N/A	Flare Traversable LT?	N/A	N/A	Flare Traversable RT?	N/A
N/A	Landing Length (in)	N/A	N/A	DWS Provided?	N/A
N/A	Landing Width (in)	N/A	N/A	DWS Contrast?	N/A
N/A	Landing Slope (%)	N/A	N/A	DWS Length (in)	N/A
N/A	Landing X Slope (%)	N/A	N/A	DWS Full Width?	N/A
N/A	Landing Curb? (Y/N)	N/A	N/A	DWS Offset (in)	N/A
N/A	Shared Landing?	N/A			
N/A	Gutter Ponding?	N/A	N/A	Gutter Slope (%)	N/A
N/A	Gutter Lip Ht (in)	N/A	N/A	Gutter X Slope (%)	N/A
N/A	Painted X Walk1?	No	N/A	Painted X Walk2?	No
	X Walk 1 Direction	To SE		X Walk 2 Direction	To NE
N/A	X Walk 1 Width (in)	N/A	N/A	X Walk 2 Width (in)	N/A
	X Walk 1 Slope (%)	3.5		X Walk 2 Slope (%)	6.0
	X Walk 1 X Slope (%)	6.2		X Walk 2 X Slope (%)	3.2

N/A	Ramp inside XWalk1?	N/A	N/A	Ramp inside XWalk2?	N/A
	Road Slope (%)	3.4	N/A	Clear Space?	N/A
	Road X Slope (%)	6.4	N/A	Clear Space to XWalk (in)	N/A
N/A	Any Obstructions?	N/A	N/A	Storm Grate/Utility Hazard?	N/A
	Obstruction Type			Storm Grate/Utility Type	
		N/A			N/A
		Yes		Surface Condition? (G/P)	Good

Remove & Replace Curb Ramp With Two New Directional Ramps or Equivalent.
