Access Compliance Report

Public Rights-of-Way

(Curb Ramps)

Intersection ID: 14671	Main Street: DRESDEN_DR_WEST	Cross Street: WOODLAND_DR	Location: S
ADA ID: DCD25A890754	Ramp Type: PerpDiag	Initial Pass/Fail: Fail	Overall Compliance: No
Codes/Mitigation Info/Possible Solution		Field Measurements/Component Compliance

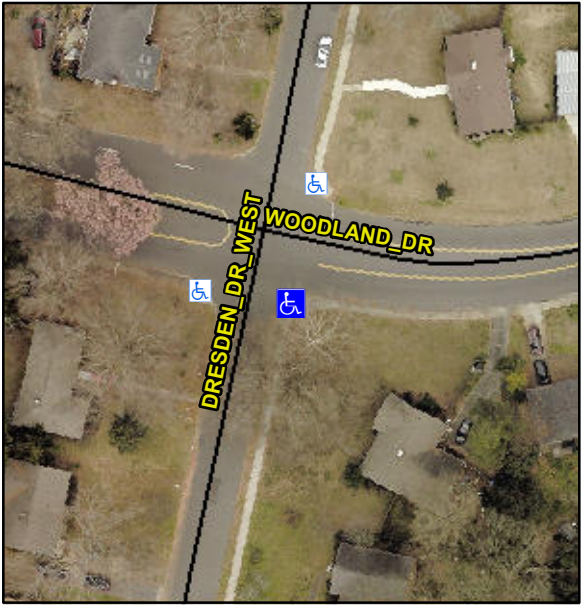
Compliance	Description	Data	Compliance	Description	Data
N/A	Ramp Length (in)	74.0	Yes	Ramp Slope (%)	5.4
No	Ramp Width (in)	45.5	Yes	Ramp XSlope (%)	0.0
N/A	Flare Type LT	N/A	N/A	Flare Type RT	N/A
N/A	Flare Slope LT (%)	N/A	N/A	Flare Slope RT (%)	N/A
N/A	Flare Traversable LT?	N/A	N/A	Flare Traversable RT?	N/A
N/A	Landing Length (in)	N/A	N/A	DWS Provided?	N/A
N/A	Landing Width (in)	N/A	N/A	DWS Contrast?	N/A
N/A	Landing Slope (%)	N/A	N/A	DWS Length (in)	N/A
N/A	Landing X Slope (%)	N/A	N/A	DWS Full Width?	N/A
N/A	Landing Curb? (Y/N)	N/A	N/A	DWS Offset (in)	N/A
N/A	Shared Landing?	N/A			
N/A	Gutter Ponding?	N/A	N/A	Gutter Slope (%)	N/A
N/A	Gutter Lip Ht (in)	N/A	N/A	Gutter X Slope (%)	N/A
N/A	Painted X Walk1?	No	N/A	Painted X Walk2?	No
	X Walk 1 Direction	To NE		X Walk 2 Direction	To NW
N/A	X Walk 1 Width (in)	N/A	N/A	X Walk 2 Width (in)	N/A
	X Walk 1 Slope (%)	5.1		X Walk 2 Slope (%)	3.1
	X Walk 1 X Slope (%)	2.8		X Walk 2 X Slope (%)	3.8

N/A	Ramp inside XWalk1?	N/A	N/A	Ramp inside XWalk2?	N/A
	Road Slope (%)	0.1	N/A	Clear Space?	N/A
	Road X Slope (%)	6.2	N/A	Clear Space to XWalk (in)	N/A
N/A	Any Obstructions?	N/A	N/A	Storm Grate/Utility Hazard?	N/A
	Obstruction Type			Storm Grate/Utility Type	
		N/A			N/A
			Yes	Surface Condition? (G/P)	Good

Possible Solutions:						
	Remove & Replace Curb Ramp With Two New Directional Ramps or Equivalent.						
	Surveyor Notes:						
	N/A						
	PROW/ADA:						
	Not Found, R304.5.1						
Street 1 Name	WOODLAND DR						
Stop Condition-Street 2	None						
Street 2 Name	DRESDEN DR WEST						
Stop Condition-Street 1	StopSign						
Total Cost:		\$	3200.00
