Access Compliance Report

Public Rights-of-Way

(Curb Ramps)

Intersection ID: 27286	Main Street: ELMSTONE_DR	Cross Street: THORNHILL_CLUB_DR	Location: E
ADA ID: DCEA2C3DC7B5	Ramp Type: PerpDiag	Initial Pass/Fail: Pass	Overall Compliance: No
Severity Score: 10.25			
Codes/Mitigation Info/Possible Solution		Field Measurements/Component Compliance

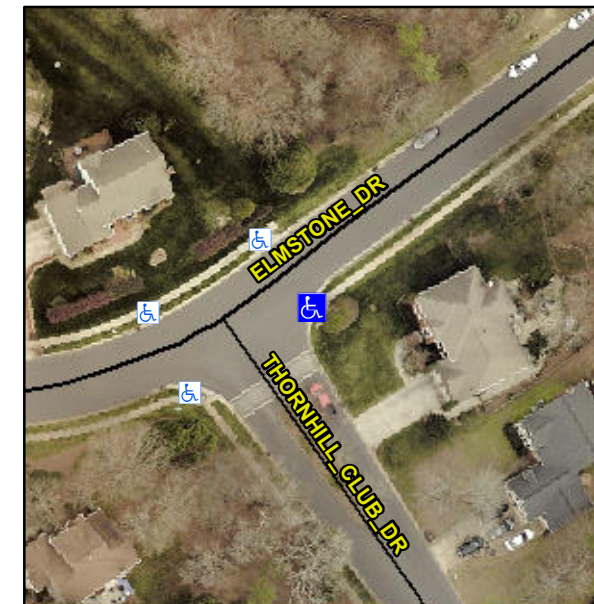
Compliance	Description	Data	Compliance	Description	Data
N/A	Ramp Length (in)	78.0	Yes	Ramp Slope (%)	7.2
Yes	Ramp Width (in)	48.0	No	Ramp XSlope (%)	2.4
N/A	Flare Type LT	Sloped	N/A	Flare Type RT	N/A
N/A	Flare Slope LT (%)	0.7	N/A	Flare Slope RT (%)	6.2
N/A	Flare Traversable LT?	Yes	N/A	Flare Traversable RT?	No
No	Landing Length (in)	N/A	Yes	DWS Provided?	Yes
No	Landing Width (in)	N/A	Yes	DWS Contrast?	Yes
No	Landing Slope (%)	N/A	Yes	DWS Length (in)	24.0
No	Landing X Slope (%)	N/A	Yes	DWS Full Width?	Yes
N/A	Landing Curb? (Y/N)	No	No	DWS Offset (in)	9.0
N/A	Shared Landing?	N/A			
Yes	Gutter Ponding?	No	Yes	Gutter Slope (%)	1.4
Yes	Gutter Lip Ht (in)	0.0	No	Gutter X Slope (%)	3.0
N/A	Painted X Walk1?	No	N/A	Painted X Walk2?	No
	X Walk 1 Direction	To NW		X Walk 2 Direction	To SW
N/A	X Walk 1 Width (in)	N/A	N/A	X Walk 2 Width (in)	N/A
	X Walk 1 Slope (%)	2.4		X Walk 2 Slope (%)	3.7
	X Walk 1 X Slope (%)	3.4		X Walk 2 X Slope (%)	1.7

N/A	Ramp inside XWalk1?	N/A	N/A	Ramp inside XWalk2?	N/A
	Road Slope (%)	1.7	N/A	Clear Space?	Yes
	Road X Slope (%)	4.6	N/A	Clear Space to XWalk (in)	N/A
Yes	Any Obstructions?	No	Yes	Storm Grate/Utility Hazard?	No
	Obstruction Type			Storm Grate/Utility Type	
		N/A			N/A
			Yes	Surface Condition? (G/P)	Good

Remove & Replace Curb Ramp With Two New Directional Ramps or Equivalent. Remove & Replace Gutter.
