Intersection ID: 19285	Main Street: GLENROCK_DR	Cross Street: NATIONS_FORD_RD	Location:	SW
ADA ID: DCEAF1E668C6	Ramp Type: PerpDiag	Initial Pass/Fail: Fail	Overall Compliance: No	Severity Score: 12.5

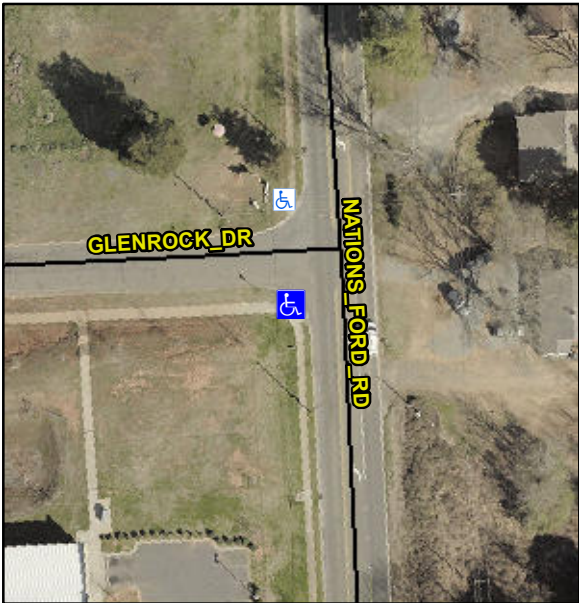
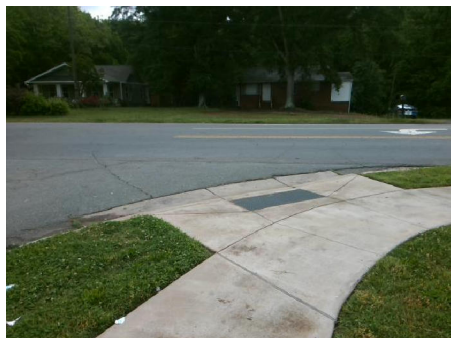
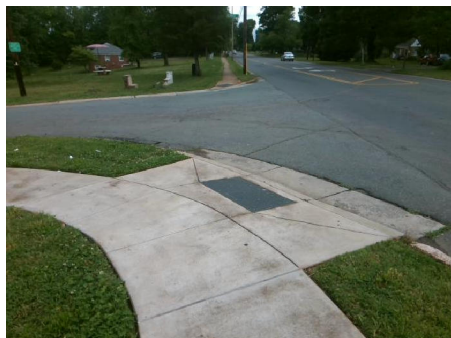
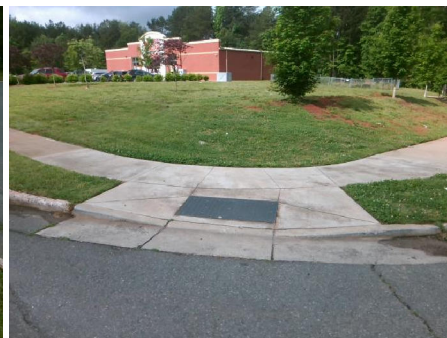
Possible Solutions:		Compliance	Description	Data	Compliance	Description	Data
	Remove & Replace Curb Ramp With Two New Directional Ramps or Equivalent.		N/A	Ramp Length (in)	42.0	No	Ramp Slope (%)	9.8
			Yes	Ramp Width (in)	48.0	Yes	Ramp XSlope (%)	1.2
			N/A	Flare Type LT	N/A	N/A	Flare Type RT	N/A
			N/A	Flare Slope LT (%)	N/A	N/A	Flare Slope RT (%)	N/A
			N/A	Flare Traversable LT?	N/A	N/A	Flare Traversable RT?	N/A
	Surveyor Notes:		N/A	Landing Length (in)	N/A	N/A	DWS Provided?	N/A
			N/A	Landing Width (in)	N/A	N/A	DWS Contrast?	N/A
			N/A	Landing Slope (%)	N/A	N/A	DWS Length (in)	N/A
			N/A	Landing X Slope (%)	N/A	N/A	DWS Full Width?	N/A
N/A			Landing Curb? (Y/N)	N/A	N/A	DWS Offset (in)	N/A	
PROW/ADA:		N/A	Shared Landing?	N/A				
R304.2.2		N/A	Gutter Ponding?	N/A	N/A	Gutter Slope (%)	N/A	
		N/A	Gutter Lip Ht (in)	N/A	N/A	Gutter X Slope (%)	N/A

N/A	Painted X Walk1?	No	N/A	Painted X Walk2?	No	
			X Walk 1 Direction	To E		X Walk 2 Direction	To N	
		N/A	X Walk 1 Width (in)	N/A	N/A	X Walk 2 Width (in)	N/A	
			X Walk 1 Slope (%)	4.6		X Walk 2 Slope (%)	1.0	
			X Walk 1 X Slope (%)	0.7		X Walk 2 X Slope (%)	4.2	
		N/A	Ramp inside XWalk1?	N/A	N/A	Ramp inside XWalk2?	N/A	
			Road Slope (%)	0.7	N/A	Clear Space?	N/A	
			Road X Slope (%)	5.5	N/A	Clear Space to XWalk (in)	N/A	
		N/A	Any Obstructions?	N/A	N/A	Storm Grate/Utility Hazard?	N/A	
			Obstruction Type			Storm Grate/Utility Type		
					N/A			N/A
						Yes	Surface Condition? (G/P)	Good
Street 1 Name		NATIONS FORD RD						
Stop Condition-Street 2		None						
Street 2 Name		GLENROCK DR						
Stop Condition-Street 1		StopSign						
Total Cost:		\$ 3200.00
