# Access Compliance Report

## Public Rights-of-Way

Intersection ID: 44453	Main Street: BAYVIEW_PY	Cross Street: RUMNEY_CT	Location: NE
ADA ID: DCF880B6B172	Ramp Type: PerpDiag	Initial Pass/Fail: Fail	Overall Compliance: No
Codes/Mitigation Info/Possible Solution			Severity Score: 10
Field Measurements/Component Compliance

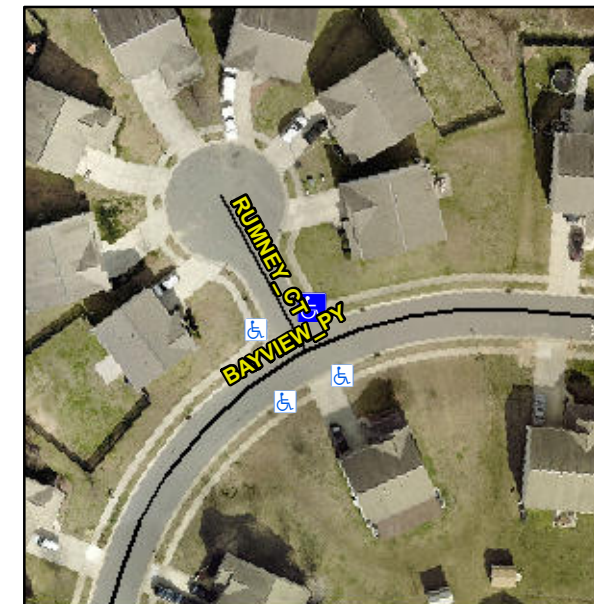
Compliance	Description	Data	Compliance	Description	Data
N/A	Ramp Length (in)	48.0	Yes	Ramp Slope (%)	5.8
No	Ramp Width (in)	47.0	No	Ramp XSlope (%)	2.3
N/A	Flare Type LT	N/A	N/A	Flare Type RT	N/A
N/A	Flare Slope LT (%)	N/A	N/A	Flare Slope RT (%)	N/A
N/A	Flare Traversable LT?	N/A	N/A	Flare Traversable RT?	N/A
N/A	Landing Length (in)	N/A	N/A	DWS Provided?	N/A
N/A	Landing Width (in)	N/A	N/A	DWS Contrast?	N/A
N/A	Landing Slope (%)	N/A	N/A	DWS Length (in)	N/A
N/A	Landing X Slope (%)	N/A	N/A	DWS Full Width?	N/A
N/A	Landing Curb? (Y/N)	N/A	N/A	DWS Offset (in)	N/A
N/A	Shared Landing?	N/A			
N/A	Gutter Ponding?	N/A	N/A	Gutter Slope (%)	N/A
N/A	Gutter Lip Ht (in)	N/A	N/A	Gutter X Slope (%)	N/A
N/A	Painted X Walk1?	No	N/A	Painted X Walk2?	No
	X Walk 1 Direction	To W		X Walk 2 Direction	To S
N/A	X Walk 1 Width (in)	N/A	N/A	X Walk 2 Width (in)	N/A
	X Walk 1 Slope (%)	2.1		X Walk 2 Slope (%)	0.3
	X Walk 1 X Slope (%)	1.0		X Walk 2 X Slope (%)	1.0

N/A	Ramp inside XWalk1?	N/A	N/A	Ramp inside XWalk2?	N/A
	Road Slope (%)	1.9	N/A	Clear Space?	N/A
	Road X Slope (%)	0.9	N/A	Clear Space to XWalk (in)	N/A
N/A	Any Obstructions?	N/A	N/A	Storm Grate/Utility Hazard?	N/A
	Obstruction Type			Storm Grate/Utility Type	
		N/A			N/A
			Yes	Surface Condition? (G/P)	Good

**Remove & Replace Curb Ramp With Two New Directional Ramps or Equivalent.**
