Access Compliance Report Public Rights-of-Way (Curb Ramps)

Intersection ID: 50248 Main Street: HANBERRY BV **Cross Street: DERRYRUSH DR** Location: SE ADA ID: DCFFD8340E36 Ramp Type: PerpDiag Initial Pass/Fail: Fail **Overall Compliance: No** Severity Score: 21.25

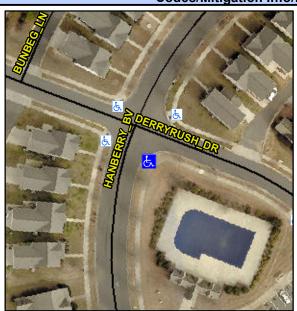
Compliance Description		Data	Compli	ance	Description	Data	
	N/A	Ramp Length (in)	72.0	No	Ramp	Slope (%)	9.1
	No	Ramp Width (in)	46.0	Yes	Ramp	XSlope (%)	0.6
ı	N/A	Flare Type LT	N/A	N/A	Flare	Type RT	N/A
	N/A	Flare Slope LT (%)	N/A	N/A	Flare	Slope RT (%)	N/A
	N/A	Flare Traversable LT?	N/A	N/A	Flare	Traversable RT?	N/A
	N/A	Landing Length (in)	N/A	N/A	DWS	Provided?	N/A
	N/A	Landing Width (in)	N/A	N/A	DWS	Contrast?	N/A
	N/A	Landing Slope (%)	N/A	N/A	DWS	Length (in)	N/A
	N/A	Landing X Slope (%)	N/A	N/A	DWS	Full Width?	N/A
	N/A	Landing Curb? (Y/N)	N/A	N/A	DWS	Offset (in)	N/A
	N/A	Shared Landing?	N/A				
	N/A	Gutter Ponding?	N/A	N/A	Gutte	r Slope (%)	N/A
	N/A	Gutter Lip Ht (in)	N/A	N/A	Gutte	r X Slope (%)	N/A
	N/A	Painted X Walk1?	No	N/A	Painte	ed X Walk2?	No
		X Walk 1 Direction	To NE		X Wa	lk 2 Direction	To NW
	N/A	X Walk 1 Width (in)	N/A	N/A	X Wa	lk 2 Width (in)	N/A
		X Walk 1 Slope (%)	1.3		X Wa	lk 2 Slope (%)	2.7

Remove & Replace Curb Ramp With Two New Directional Ramps or Equivalent.
