# Access Compliance Report

## Public Rights-of-Way

### (Curb Ramps)

Intersection ID: 20954	Main Street: SHARON_VIEW_RD	Cross Street: SOUTH_HILL_VIEW_DR	Location: NW
ADA ID: DD038680FDE7	Ramp Type: PerpDiag	Initial Pass/Fail: Fail	Overall Compliance: No
Severity Score: 22.5			
Codes/Mitigation Info/Possible Solution		Field Measurements/Component Compliance

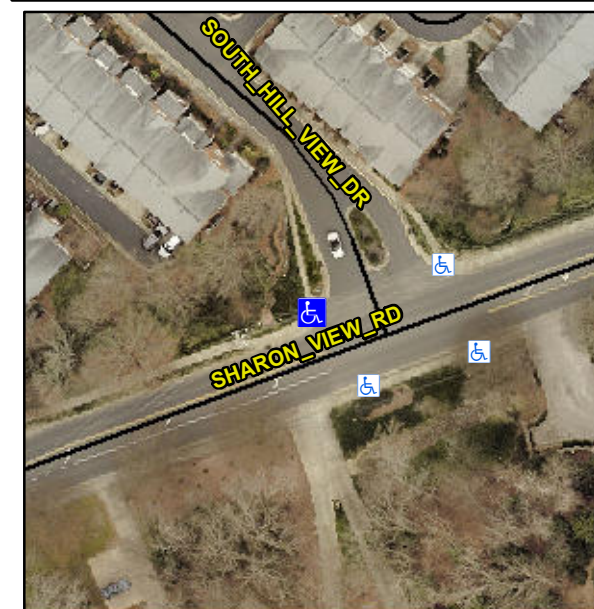
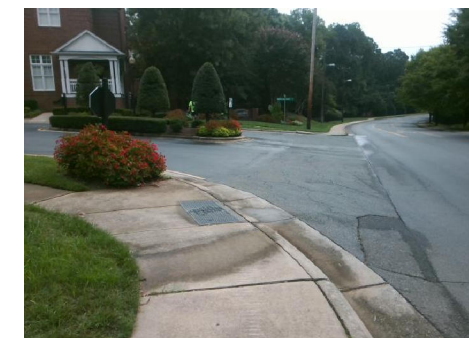
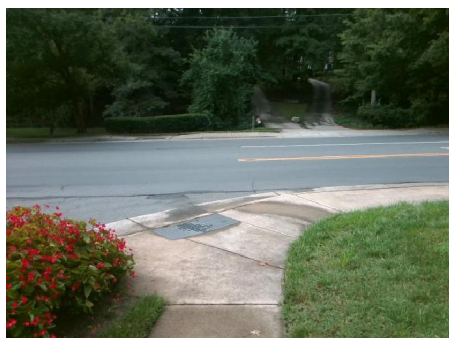
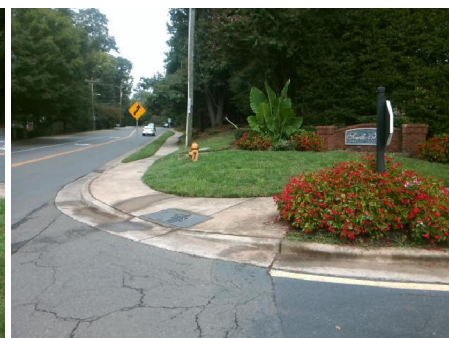
Compliance	Description	Data	Compliance	Description	Data
N/A	Ramp Length (in)	76.5	No	Ramp Slope (%)	9.6
No	Ramp Width (in)	37.0	No	Ramp XSlope (%)	2.9
N/A	Flare Type LT	N/A	N/A	Flare Type RT	N/A
N/A	Flare Slope LT (%)	N/A	N/A	Flare Slope RT (%)	N/A
N/A	Flare Traversable LT?	N/A	N/A	Flare Traversable RT?	N/A
N/A	Landing Length (in)	N/A	N/A	DWS Provided?	N/A
N/A	Landing Width (in)	N/A	N/A	DWS Contrast?	N/A
N/A	Landing Slope (%)	N/A	N/A	DWS Length (in)	N/A
N/A	Landing X Slope (%)	N/A	N/A	DWS Full Width?	N/A
N/A	Landing Curb? (Y/N)	N/A	N/A	DWS Offset (in)	N/A
N/A	Shared Landing?	N/A			
N/A	Gutter Ponding?	N/A	N/A	Gutter Slope (%)	N/A
N/A	Gutter Lip Ht (in)	N/A	N/A	Gutter X Slope (%)	N/A
N/A	Painted X Walk1?	No	N/A	Painted X Walk2?	No
	X Walk 1 Direction	To SE		X Walk 2 Direction	To NE
N/A	X Walk 1 Width (in)	N/A	N/A	X Walk 2 Width (in)	N/A
	X Walk 1 Slope (%)	10.4		X Walk 2 Slope (%)	4.9
	X Walk 1 X Slope (%)	6.2		X Walk 2 X Slope (%)	7.7

N/A	Ramp inside XWalk1?	N/A	N/A	Ramp inside XWalk2?	N/A
	Road Slope (%)	3.5	N/A	Clear Space?	N/A
	Road X Slope (%)	14.2	N/A	Clear Space to XWalk (in)	N/A
N/A	Any Obstructions?	N/A	N/A	Storm Grate/Utility Hazard?	N/A
	Obstruction Type			Storm Grate/Utility Type	
		N/A			N/A
			Yes	Surface Condition? (G/P)	Good

**Remove & Replace Curb Ramp With Two New Directional Ramps or Equivalent.**
