# Access Compliance Report

## Public Rights-of-Way

### (Curb Ramps)

Intersection ID: 6715	Main Street: ONEIDA_RD	Cross Street: TEWKESBURY_RD	Location: S
ADA ID: DD51D12B4979	Ramp Type: Perp	Initial Pass/Fail: Fail	Overall Compliance: No
Severity Score: 37.5			
Codes/Mitigation Info/Possible Solution		Field Measurements/Component Compliance

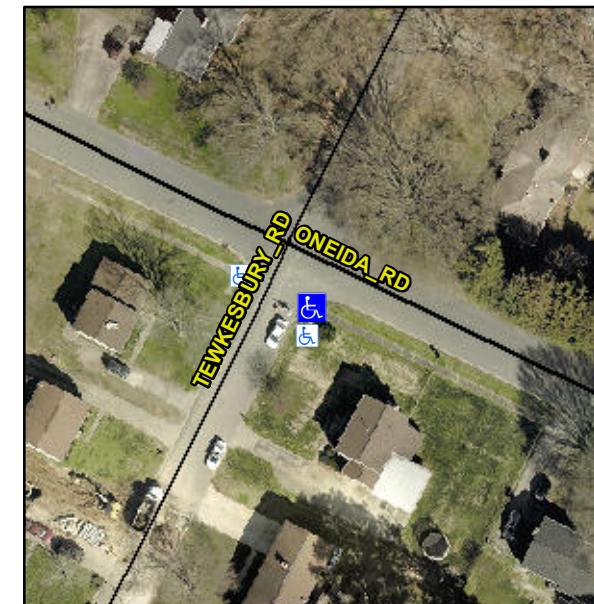
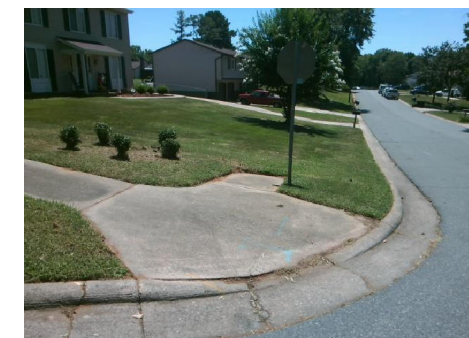
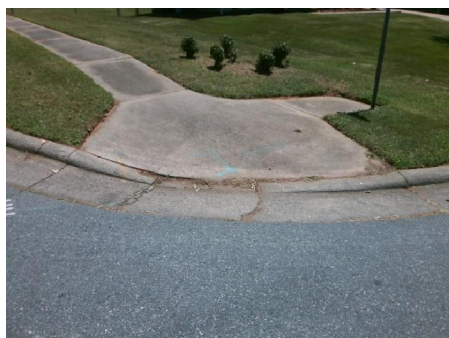
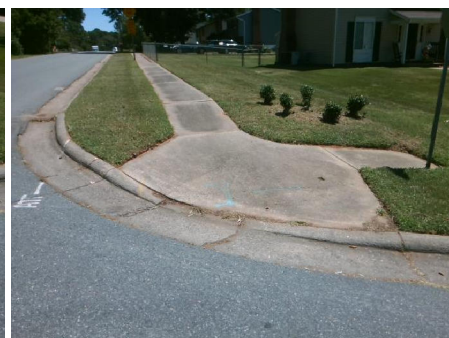
**Not Found, R304.2.2, R304.5.3**

Compliance	Description	Data	Compliance	Description	Data
N/A	Ramp Length (in)	68.0	No	Ramp Slope (%)	9.0
Yes	Ramp Width (in)	48.0	No	Ramp XSlope (%)	9.5
N/A	Flare Type LT	N/A	N/A	Flare Type RT	N/A
N/A	Flare Slope LT (%)	N/A	N/A	Flare Slope RT (%)	N/A
N/A	Flare Traversable LT?	N/A	N/A	Flare Traversable RT?	N/A
N/A	Landing Length (in)	N/A	N/A	DWS Provided?	N/A
N/A	Landing Width (in)	N/A	N/A	DWS Contrast?	N/A
N/A	Landing Slope (%)	N/A	N/A	DWS Length (in)	N/A
N/A	Landing X Slope (%)	N/A	N/A	DWS Full Width?	N/A
N/A	Landing Curb? (Y/N)	N/A	N/A	DWS Offset (in)	N/A
N/A	Shared Landing?	N/A			
N/A	Gutter Ponding?	N/A	N/A	Gutter Slope (%)	N/A
N/A	Gutter Lip Ht (in)	N/A	N/A	Gutter X Slope (%)	N/A
N/A	Painted X Walk1?	No	N/A	Painted X Walk2?	N/A
	X Walk 1 Direction	To NW		X Walk 2 Direction	N/A
N/A	X Walk 1 Width (in)	N/A	N/A	X Walk 2 Width (in)	N/A
	X Walk 1 Slope (%)	1.1		X Walk 2 Slope (%)	N/A
	X Walk 1 X Slope (%)	9.9		X Walk 2 X Slope (%)	N/A

N/A	Ramp inside XWalk1?	N/A	N/A	Ramp inside XWalk2?	N/A
	Road Slope (%)	N/A	N/A	Clear Space?	N/A
	Road X Slope (%)	N/A	N/A	Clear Space to XWalk (in)	N/A
N/A	Any Obstructions?	N/A	N/A	Storm Grate/Utility Hazard?	N/A
	Obstruction Type			Storm Grate/Utility Type	
		N/A			N/A
			Yes	Surface Condition? (G/P)	Good

**Remove & Replace Entire Ramp.**

Total Cost: \$ 1850.00
