Access Compliance Report

Public Rights-of-Way

(Curb Ramps)

Intersection ID: 12419	Main Street: OTTS_ST	Cross Street: SEIGLE_AV	Location: S
ADA ID: DD58C814B011	Ramp Type: PerpDiag	Initial Pass/Fail: Fail	Overall Compliance: No
Codes/Mitigation Info/Possible Solution		Field Measurements/Component Compliance	
Severity Score: 13.75

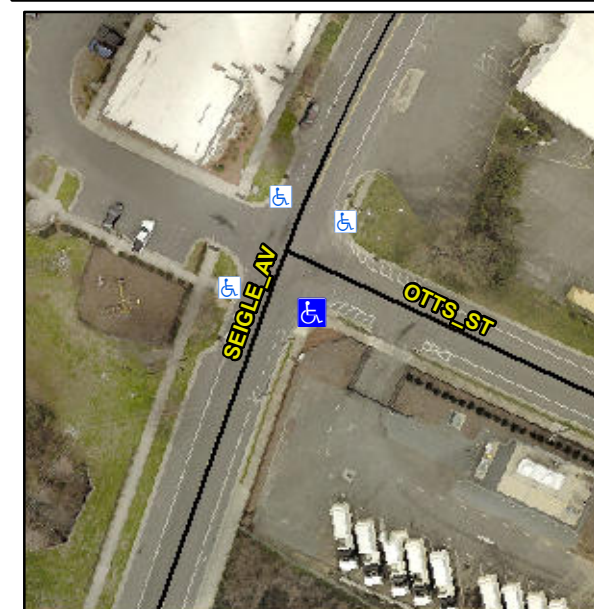
Compliance	Description	Data	Compliance	Description	Data
N/A	Ramp Length (in)	38.0	No	Ramp Slope (%)	8.4
Yes	Ramp Width (in)	48.0	No	Ramp XSlope (%)	4.8
N/A	Flare Type LT	N/A	N/A	Flare Type RT	N/A
N/A	Flare Slope LT (%)	N/A	N/A	Flare Slope RT (%)	N/A
N/A	Flare Traversable LT?	N/A	N/A	Flare Traversable RT?	N/A
N/A	Landing Length (in)	N/A	N/A	DWS Provided?	N/A
N/A	Landing Width (in)	N/A	N/A	DWS Contrast?	N/A
N/A	Landing Slope (%)	N/A	N/A	DWS Length (in)	N/A
N/A	Landing X Slope (%)	N/A	N/A	DWS Full Width?	N/A
N/A	Landing Curb? (Y/N)	N/A	N/A	DWS Offset (in)	N/A
N/A	Shared Landing?	N/A			
N/A	Gutter Ponding?	N/A	N/A	Gutter Slope (%)	N/A
N/A	Gutter Lip Ht (in)	2.0	N/A	Gutter X Slope (%)	N/A
N/A	Painted X Walk1?	No	N/A	Painted X Walk2?	No
	X Walk 1 Direction	To NE		X Walk 2 Direction	To NW
N/A	X Walk 1 Width (in)	N/A	N/A	X Walk 2 Width (in)	N/A
	X Walk 1 Slope (%)	4.4		X Walk 2 Slope (%)	1.8
	X Walk 1 X Slope (%)	1.8		X Walk 2 X Slope (%)	5.5

N/A	Ramp inside XWalk1?	N/A	N/A	Ramp inside XWalk2?	N/A
	Road Slope (%)	3.8	N/A	Clear Space?	N/A
	Road X Slope (%)	3.2	N/A	Clear Space to XWalk (in)	N/A
N/A	Any Obstructions?	N/A	N/A	Storm Grate/Utility Hazard?	N/A
	Obstruction Type			Storm Grate/Utility Type	
		N/A			N/A
		Yes		Surface Condition? (G/P)	Good

Possible Solutions:

Remove & Replace Curb Ramp With Two New Directional Ramps or Equivalent.
