Access Compliance Report

Public Rights-of-Way

(Curb Ramps)

Intersection ID: 11972	Main Street: N_POPLAR_ST	Cross Street: W_5TH_ST	Location: E
ADA ID: DD67202AF795	Ramp Type: PerpDiag	Initial Pass/Fail: Fail	Overall Compliance: No
		Severity Score: 12.5

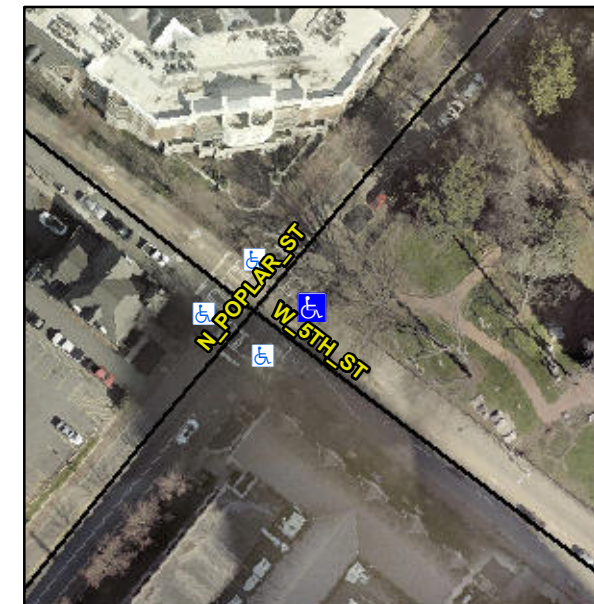
Compliance	Description	Data	Compliance	Description	Data
N/A	Ramp Length (in)	77.0	Yes	Ramp Slope (%)	5.7
Yes	Ramp Width (in)	48.0	No	Ramp XSlope (%)	5.1
N/A	Flare Type LT	N/A	N/A	Flare Type RT	N/A
N/A	Flare Slope LT (%)	N/A	N/A	Flare Slope RT (%)	N/A
N/A	Flare Traversable LT?	N/A	N/A	Flare Traversable RT?	N/A
N/A	Landing Length (in)	N/A	N/A	DWS Provided?	N/A
N/A	Landing Width (in)	N/A	N/A	DWS Contrast?	N/A
N/A	Landing Slope (%)	N/A	N/A	DWS Length (in)	N/A
N/A	Landing X Slope (%)	N/A	N/A	DWS Full Width?	N/A
N/A	Landing Curb? (Y/N)	N/A	N/A	DWS Offset (in)	N/A
N/A	Shared Landing?	N/A			
N/A	Gutter Ponding?	N/A	N/A	Gutter Slope (%)	N/A
N/A	Gutter Lip Ht (in)	N/A	N/A	Gutter X Slope (%)	N/A
N/A	Painted X Walk1?	Yes	N/A	Painted X Walk2?	Yes
	X Walk 1 Direction	To NW		X Walk 2 Direction	To SW
N/A	X Walk 1 Width (in)	112.0	N/A	X Walk 2 Width (in)	112.0
	X Walk 1 Slope (%)	1.6		X Walk 2 Slope (%)	3.0
	X Walk 1 X Slope (%)	7.6		X Walk 2 X Slope (%)	1.0

N/A	Ramp inside XWalk1?	Yes	N/A	Ramp inside XWalk2?	Yes
	Road Slope (%)	0.9	N/A	Clear Space?	N/A
	Road X Slope (%)	2.0	N/A	Clear Space to XWalk (in)	N/A
N/A	Any Obstructions?	N/A	N/A	Storm Grate/Utility Hazard?	N/A
	Obstruction Type			Storm Grate/Utility Type	
		N/A			N/A
		Yes		Surface Condition? (G/P)	Good

Remove & Replace Curb Ramp With Two New Directional Ramps or Equivalent.

R304.5.3
