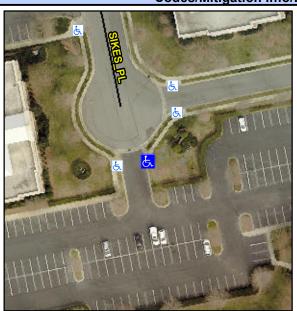
Intersection ID: 10038086Main Street: SIKES_PLCross Street: N/ALocation:SEADA ID: DD69C9D1CB60Ramp Type: PerpInitial Pass/Fail: FailOverall Compliance: NoSeverity Score: 12.5

Field Measurements/Component Compilance							
Comp	liance Description	Data	Comp	liance Description	Data		
N/A	Ramp Length (in)	45.0	No	Ramp Slope (%)	8.7		
Yes	Ramp Width (in)	49.0	Yes	Ramp XSlope (%)	0.0		
N/A	Flare Type LT	N/A	N/A	Flare Type RT	N/A		
N/A	Flare Slope LT (%)	N/A	N/A	Flare Slope RT (%)	N/A		
N/A	Flare Traversable LT?	N/A	N/A	Flare Traversable RT?	N/A		
N/A	Landing Length (in)	N/A	N/A	DWS Provided?	N/A		
N/A	Landing Width (in)	N/A	N/A	DWS Contrast?	N/A		
N/A	Landing Slope (%)	N/A	N/A	DWS Length (in)	N/A		
N/A	Landing X Slope (%)	N/A	N/A	DWS Full Width?	N/A		
N/A	Landing Curb? (Y/N)	N/A	N/A	DWS Offset (in)	N/A		
N/A	Shared Landing?	N/A					
N/A	Gutter Ponding?	N/A	N/A	Gutter Slope (%)	N/A		
N/A	Gutter Lip Ht (in)	1.0	N/A	Gutter X Slope (%)	N/A		
N/A	Painted X Walk1?	No	N/A	Painted X Walk2?	N/A		
	X Walk 1 Direction	To W		X Walk 2 Direction	N/A		
N/A	X Walk 1 Width (in)	N/A	N/A	X Walk 2 Width (in)	N/A

X Walk 1 Slope (%)	1.4		X Walk 2 Slope (%)	N/A		
	X Walk 1 X Slope (%)	1.1		X Walk 2 X Slope (%)	N/A		
N/A	Ramp inside XWalk1?	N/A	N/A	Ramp inside XWalk2?	N/A		
	Road Slope (%)	N/A	N/A	Clear Space?	N/A		
	Road X Slope (%)	N/A	N/A	Clear Space to XWalk (in)	N/A		
N/A	Any Obstructions?	N/A	N/A	Storm Grate/Utility Hazard?	N/A		
	Obstruction Type		l	Storm Grate/Utility Type			
		N/A			N/A		
			Yes	Surface Condition? (G/P)	Good		
T-W	Sec. 1

Possible Solutions:					
Remove & Replace Entire Ramp.					
Surveyor Notes:					
N/A					
PROW/ADA:					
R304.2.2

Total Cost:	\$ 1850.00
