# Access Compliance Report

## Public Rights-of-Way

### (Curb Ramps)

Intersection ID: 16765	Main Street: CHURCHILL_RD	Cross Street: N_WENDOVER_RD	Location: SE
ADA ID: DD6D54CED84C	Ramp Type: PerpDiag	Initial Pass/Fail: Fail	Overall Compliance: No
Severity Score: 25			
Codes/Mitigation Info/Possible Solution		Field Measurements/Component Compliance

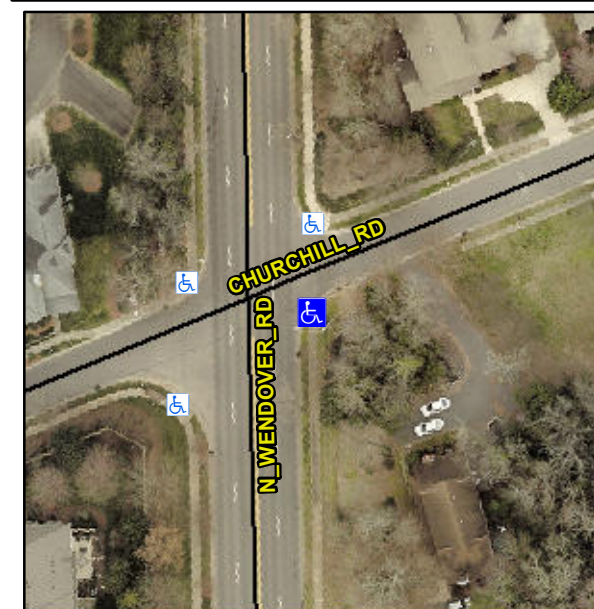
**Not Found, R304.2.2, R304.5.3**

Compliance	Description	Data	Compliance	Description	Data
N/A	Ramp Length (in)	67.0	No	Ramp Slope (%)	10.1
Yes	Ramp Width (in)	48.0	No	Ramp XSlope (%)	5.4
N/A	Flare Type LT	N/A	N/A	Flare Type RT	N/A
N/A	Flare Slope LT (%)	N/A	N/A	Flare Slope RT (%)	N/A
N/A	Flare Traversable LT?	N/A	N/A	Flare Traversable RT?	N/A
N/A	Landing Length (in)	N/A	N/A	DWS Provided?	N/A
N/A	Landing Width (in)	N/A	N/A	DWS Contrast?	N/A
N/A	Landing Slope (%)	N/A	N/A	DWS Length (in)	N/A
N/A	Landing X Slope (%)	N/A	N/A	DWS Full Width?	N/A
N/A	Landing Curb? (Y/N)	N/A	N/A	DWS Offset (in)	N/A
N/A	Shared Landing?	N/A			
N/A	Gutter Ponding?	N/A	N/A	Gutter Slope (%)	N/A
N/A	Gutter Lip Ht (in)	N/A	N/A	Gutter X Slope (%)	N/A
N/A	Painted X Walk1?	No	N/A	Painted X Walk2?	No
	X Walk 1 Direction	To NE		X Walk 2 Direction	To SW
N/A	X Walk 1 Width (in)	N/A	N/A	X Walk 2 Width (in)	N/A
	X Walk 1 Slope (%)	1.6		X Walk 2 Slope (%)	2.0
	X Walk 1 X Slope (%)	2.1		X Walk 2 X Slope (%)	4.0

N/A	Ramp inside XWalk1?	N/A	N/A	Ramp inside XWalk2?	N/A
	Road Slope (%)	4.2	N/A	Clear Space?	N/A
	Road X Slope (%)	3.9	N/A	Clear Space to XWalk (in)	N/A
N/A	Any Obstructions?	N/A	N/A	Storm Grate/Utility Hazard?	N/A
	Obstruction Type			Storm Grate/Utility Type	
		N/A			N/A
			Yes	Surface Condition? (G/P)	Good

**Remove & Replace Curb Ramp With Two New Directional Ramps or Equivalent.**

Total Cost: \$ 3200.00
