Access Compliance Report

Public Rights-of-Way (Curb Ramps)

Intersection ID: 12418	Main Street: KILBORNE_DR	Cross Street: MARKHAM_CT	Location: W
ADA ID: DD6FC6446C58	Ramp Type: Directional1	Initial Pass/Fail: Fail	Overall Compliance: No
Severity Score: 1.25			
Codes/Mitigation Info/Possible Solution		Field Measurements/Component Compliance

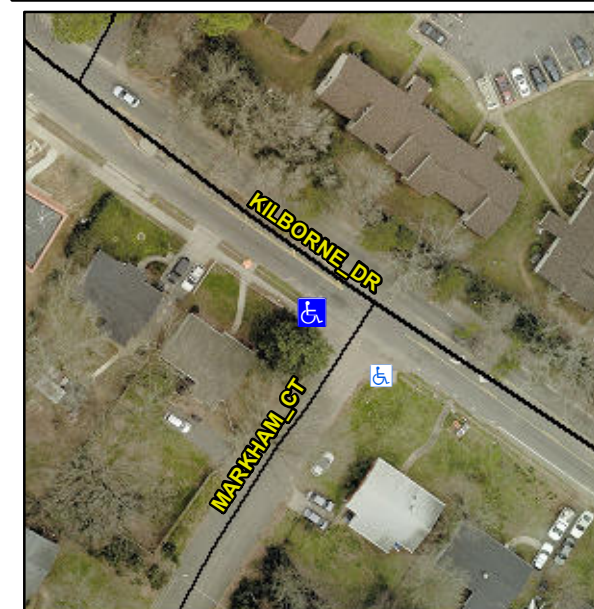
Compliance	Description	Data	Compliance	Description	Data
N/A	Ramp Length (in)	58.0	N/A	Grade Break?	N/A
Yes	Ramp Width (in)	71.0	N/A	Grade Break Slope (%)	0.0
Yes	Ramp Slope (%)	1.9	N/A	Grade Break XSlope (%)	0.0
No	Ramp XSlope (%)	4.3			
N/A	Flare Type LT	N/A	N/A	Flare Type RT	N/A
N/A	Flare Slope LT (%)	N/A	N/A	Flare Slope RT (%)	0.0
N/A	Flare Traversable LT?	N/A	N/A	Flare Traversable RT?	N/A
N/A	Landing Length (in)	0.0	N/A	DWS Provided?	N/A
N/A	Landing Width (in)	0.0	N/A	DWS Contrast?	N/A
N/A	Landing Slope (%)	0.0	N/A	DWS Length (in)	N/A
N/A	Landing X Slope (%)	0.0	N/A	DWS Full Width?	N/A
N/A	Landing Curb? (Y/N)	N/A	N/A	DWS Offset LT (in)	N/A
N/A	Shared Landing?	N/A	N/A	DWS Offset RT (in)	N/A
N/A	Gutter Ponding?	0.0	N/A	Gutter Slope (%)	N/A
N/A	Gutter Lip Ht (in)	0.0	N/A	Gutter X Slope (%)	N/A
N/A	Painted X Walk1?	No		Road Slope (%)	9.5
	X Walk 1 Direction	To SE		Road X Slope (%)	2.3
	X Walk 1 Width (in)	N/A		Clear Space?	N/A

X Walk 1 Slope (%)	9.5	N/A	Clear Space to XWalk (in)	N/A
	X Walk 1 X Slope (%)	2.3	N/A	Storm Grate/Utility Hazard?	N/A
N/A	Ramp inside XWalk1?	N/A		Storm Grate/Utility Type	
N/A	Any Obstructions?	N/A			N/A
	Obstruction Type		Yes	Surface Condition? (G/P)	Good
			N/A	Curb Slope (%)	7.9

Possible Solutions:

Remove & Replace Entire Ramp.

R304.5.3
