# Access Compliance Report

## Public Rights-of-Way

### (Curb Ramps)

Intersection ID: 48409	Main Street: GLADWYNE_PL	Cross Street: BRYN_ATHYN_CT	Location: SE
ADA ID: DD77B0663597	Ramp Type: PerpDiag	Initial Pass/Fail: Fail	Overall Compliance: No
		Severity Score: 13.75

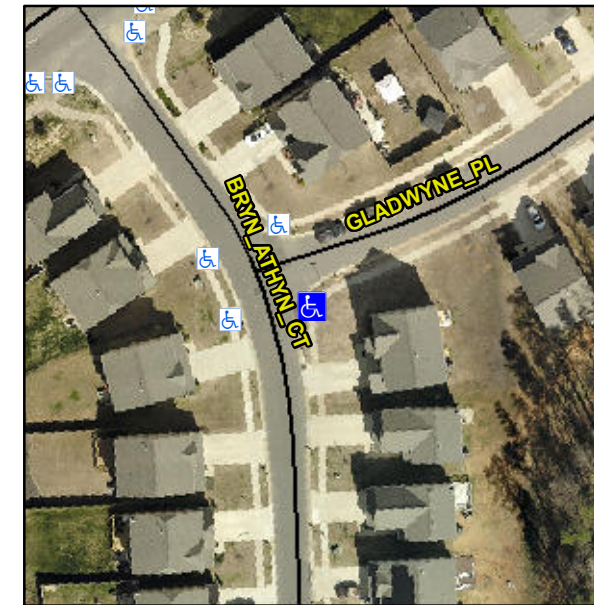
**Not Found, R304.2.2, R304.5.3**

Compliance	Description	Data	Compliance	Description	Data
N/A	Ramp Length (in)	46.5	No	Ramp Slope (%)	9.3
Yes	Ramp Width (in)	48.0	No	Ramp XSlope (%)	3.1
N/A	Flare Type LT	N/A	N/A	Flare Type RT	N/A
N/A	Flare Slope LT (%)	N/A	N/A	Flare Slope RT (%)	N/A
N/A	Flare Traversable LT?	N/A	N/A	Flare Traversable RT?	N/A
N/A	Landing Length (in)	N/A	N/A	DWS Provided?	N/A
N/A	Landing Width (in)	N/A	N/A	DWS Contrast?	N/A
N/A	Landing Slope (%)	N/A	N/A	DWS Length (in)	N/A
N/A	Landing X Slope (%)	N/A	N/A	DWS Full Width?	N/A
N/A	Landing Curb? (Y/N)	N/A	N/A	DWS Offset (in)	N/A
N/A	Shared Landing?	N/A			
N/A	Gutter Ponding?	N/A	N/A	Gutter Slope (%)	N/A
N/A	Gutter Lip Ht (in)	N/A	N/A	Gutter X Slope (%)	N/A
N/A	Painted X Walk1?	No	N/A	Painted X Walk2?	No
	X Walk 1 Direction	To N		X Walk 2 Direction	To W
N/A	X Walk 1 Width (in)	N/A	N/A	X Walk 2 Width (in)	N/A
	X Walk 1 Slope (%)	1.7		X Walk 2 Slope (%)	2.2
	X Walk 1 X Slope (%)	1.2		X Walk 2 X Slope (%)	2.6

N/A	Ramp inside XWalk1?	N/A	N/A	Ramp inside XWalk2?	N/A
	Road Slope (%)	2.3	N/A	Clear Space?	N/A
	Road X Slope (%)	0.6	N/A	Clear Space to XWalk (in)	N/A
N/A	Any Obstructions?	N/A	N/A	Storm Grate/Utility Hazard?	N/A
	Obstruction Type			Storm Grate/Utility Type	
		N/A			N/A
			Yes	Surface Condition? (G/P)	Good

**Remove & Replace Curb Ramp With Two New Directional Ramps or Equivalent.**
