# Access Compliance Report

## Public Rights-of-Way

| Intersection ID: 14633 | Main Street: E_KINGSTON_AV | Cross Street: PARK_RD | Location: W |
| ADA ID: DD77C5BA51B3 | Ramp Type: Perp | Initial Pass/Fail: Fail | Overall Compliance: No |

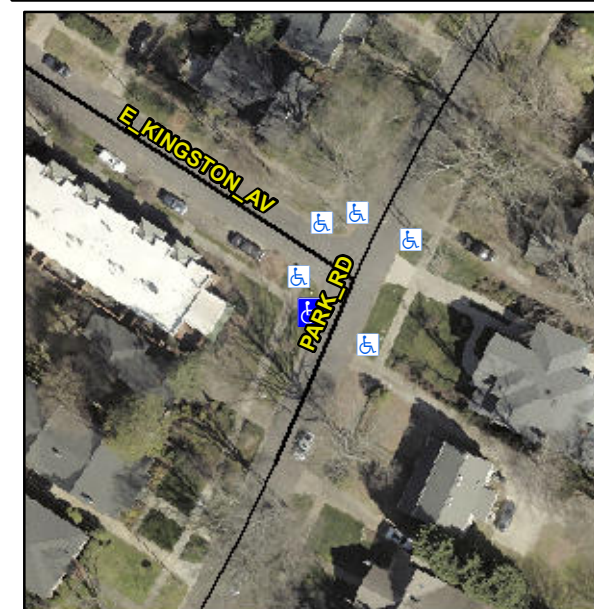
| Severity Score: 13.75 | | | |

**Not Found, R304.2.2**

| Compliance | Description | Data | Compliance | Description | Data |
|---|---|---|---|---|---|
| N/A | Ramp Length (in) | 57.0 | No | Ramp Slope (%) | 9.3 |

**Remove & Replace Entire Ramp.**

Total Cost: \$ 1850.00
