Intersection ID: 22310	Main Street: OAK_CREEK_DR	Cross Street: SARDIS_RD	Location:	NE
ADA ID: DD7A353CAD5C	Ramp Type: PerpDiag	Initial Pass/Fail: Fail	Overall Compliance: No	Severity Score: 47.5

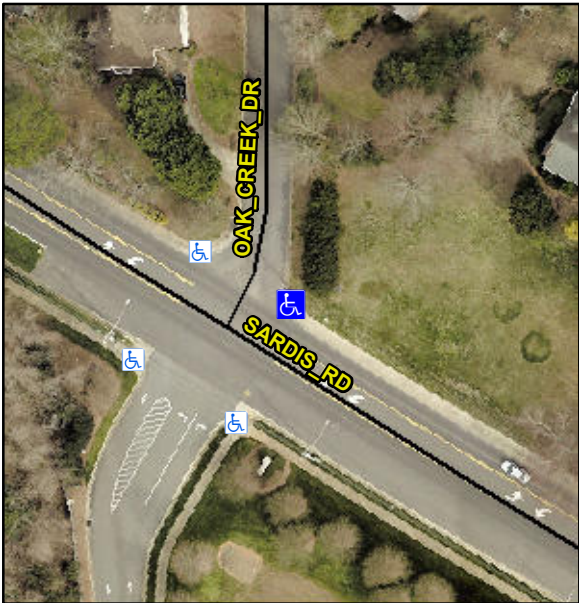
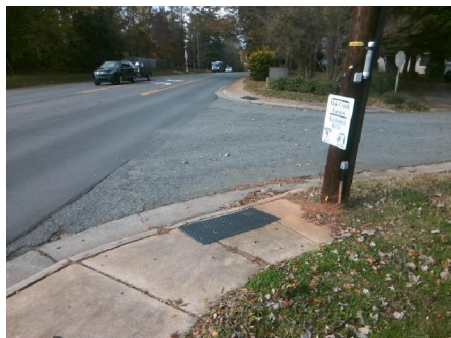
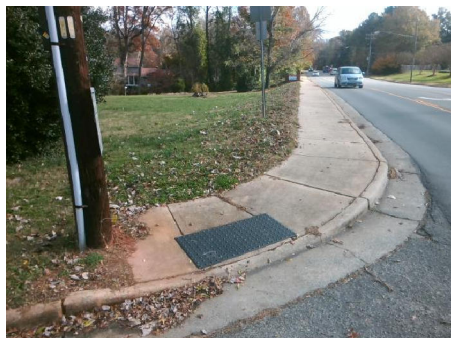
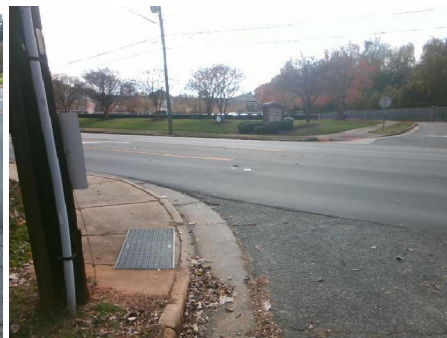
Possible Solutions:									
	Remove & Replace Curb Ramp With Two New Directional Ramps or Equivalent.									
	Surveyor Notes:									
	N/A									
	PROW/ADA:									
	Not Found, R304.5.1, R304.5.3									
	Street 1 Name		OAK CREEK DR							
	Stop Condition-Street 2		StopSign							
	Street 2 Name		SARDIS RD							
	Stop Condition-Street 1		None							
Total Cost:		\$ 3200.00								
				Compliance	Description	Data	Compliance	Description	Data	
				N/A	Ramp Length (in)	60.0	Yes	Ramp Slope (%)	6.3	
				No	Ramp Width (in)	29.0	No	Ramp XSlope (%)	6.1	
				N/A	Flare Type LT	N/A	N/A	Flare Type RT	N/A	
				N/A	Flare Slope LT (%)	N/A	N/A	Flare Slope RT (%)	N/A	
				N/A	Flare Traversable LT?	N/A	N/A	Flare Traversable RT?	N/A	
				N/A	Landing Length (in)	N/A	N/A	DWS Provided?	N/A	
				N/A	Landing Width (in)	N/A	N/A	DWS Contrast?	N/A

N/A	Landing Slope (%)	N/A	N/A	DWS Length (in)	N/A	
				N/A	Landing X Slope (%)	N/A	N/A	DWS Full Width?	N/A	
				N/A	Landing Curb? (Y/N)	N/A	N/A	DWS Offset (in)	N/A	
				N/A	Shared Landing?	N/A				
				N/A	Gutter Ponding?	N/A	N/A	Gutter Slope (%)	N/A	
				N/A	Gutter Lip Ht (in)	N/A	N/A	Gutter X Slope (%)	N/A	
				N/A	Painted X Walk1?	No	N/A	Painted X Walk2?	No	
					X Walk 1 Direction	To NW		X Walk 2 Direction	To SW	
				N/A	X Walk 1 Width (in)	N/A	N/A	X Walk 2 Width (in)	N/A	
					X Walk 1 Slope (%)	0.3		X Walk 2 Slope (%)	7.9	
					X Walk 1 X Slope (%)	6.9		X Walk 2 X Slope (%)	2.1	
				N/A	Ramp inside XWalk1?	N/A	N/A	Ramp inside XWalk2?	N/A	
					Road Slope (%)	5.9	N/A	Clear Space?	N/A	
					Road X Slope (%)	4.8	N/A	Clear Space to XWalk (in)	N/A	
				N/A	Any Obstructions?	N/A	N/A	Storm Grate/Utility Hazard?	N/A	
					Obstruction Type			Storm Grate/Utility Type		
						N/A			N/A	
							Yes	Surface Condition? (G/P)	Good
