Access Compliance Report

Public Rights-of-Way

(Curb Ramps)

| Intersection ID: N/A | Main Street: LANGWELL_LN | Cross Street: HAMILTON_BRIDGE_RD | Location: NW |

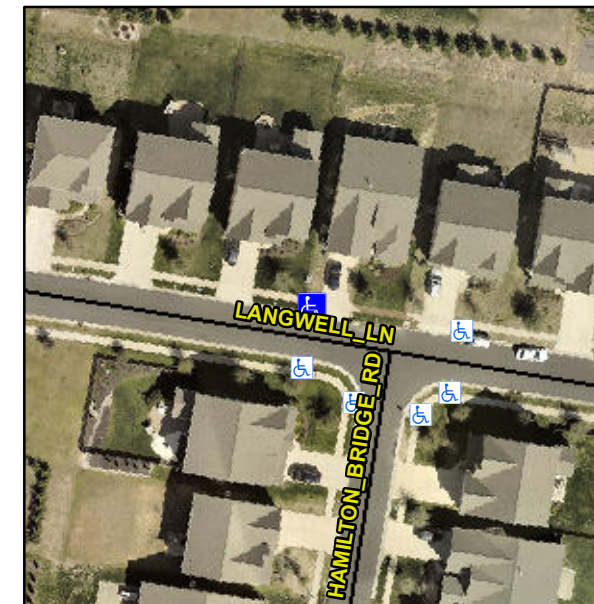
| ADA ID: DD8358BB74EF | Ramp Type: Perp | Initial Pass/Fail: Fail | Overall Compliance: No |

Not Found, R304.5.1, R304.2.2

| Compliance | Description | Data | Compliance | Description | Data |
|---|---|---|---|---|---|
| N/A | Ramp Length (in) | 47.0 | No | Ramp Slope (%) | 10.4 |
| No | Ramp Width (in) | 47.5 | Yes | Ramp XSlope (%) | 1.4 |

Possible Solutions:

Remove & Replace Entire Ramp.
