# Access Compliance Report

## Public Rights-of-Way

### (Curb Ramps)

Intersection ID: 11882	Main Street: N_PINE_ST	Cross Street: W_5TH_ST	Location: N
ADA ID: DD89CFFA98C3	Ramp Type: Perp	Initial Pass/Fail: Fail	Overall Compliance: No
		Severity Score: 12.5

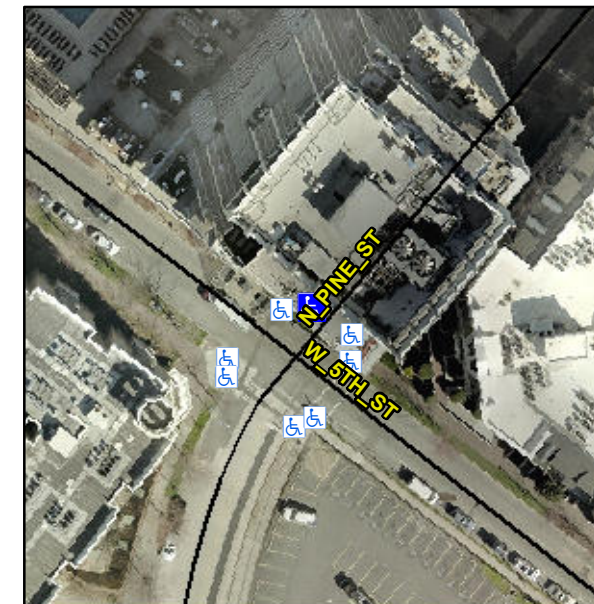
**R304.2.2**

Compliance	Description	Data	Compliance	Description	Data
N/A	Ramp Length (in)	76.0	No	Ramp Slope (%)	9.7
Yes	Ramp Width (in)	50.0	Yes	Ramp XSlope (%)	1.7
N/A	Flare Type LT	N/A	N/A	Flare Type RT	N/A
N/A	Flare Slope LT (%)	N/A	N/A	Flare Slope RT (%)	N/A
N/A	Flare Traversable LT?	N/A	N/A	Flare Traversable RT?	N/A
N/A	Landing Length (in)	N/A	N/A	DWS Provided?	N/A
N/A	Landing Width (in)	N/A	N/A	DWS Contrast?	N/A
N/A	Landing Slope (%)	N/A	N/A	DWS Length (in)	N/A
N/A	Landing X Slope (%)	N/A	N/A	DWS Full Width?	N/A
N/A	Landing Curb? (Y/N)	N/A	N/A	DWS Offset (in)	N/A
N/A	Shared Landing?	N/A			
N/A	Gutter Ponding?	N/A	N/A	Gutter Slope (%)	N/A
N/A	Gutter Lip Ht (in)	N/A	N/A	Gutter X Slope (%)	N/A
N/A	Painted X Walk1?	Yes	N/A	Painted X Walk2?	N/A
	X Walk 1 Direction	To SE		X Walk 2 Direction	N/A
N/A	X Walk 1 Width (in)	100.0	N/A	X Walk 2 Width (in)	N/A
	X Walk 1 Slope (%)	1.0		X Walk 2 Slope (%)	N/A
	X Walk 1 X Slope (%)	5.8		X Walk 2 X Slope (%)	N/A

N/A	Ramp inside XWalk1?	Yes	N/A	Ramp inside XWalk2?	N/A
	Road Slope (%)	N/A	N/A	Clear Space?	N/A
	Road X Slope (%)	N/A	N/A	Clear Space to XWalk (in)	N/A
N/A	Any Obstructions?	N/A	N/A	Storm Grate/Utility Hazard?	N/A
	Obstruction Type			Storm Grate/Utility Type	
		N/A			N/A
			Yes	Surface Condition? (G/P)	Good

**Remove & Replace Entire Ramp.**

**\$ 1850.00**
