Access Compliance Report

Public Rights-of-Way

(Curb Ramps)

Intersection ID: 31416	Main Street: BRAWER_FARM_DR	Cross Street: IRON_BRIGADE_LN	Location: W
ADA ID: DD8CE7DD71BE	Ramp Type: PerpDiag	Initial Pass/Fail: Fail	Overall Compliance: No
Codes/Mitigation Info/Possible Solution		Field Measurements/Component Compliance

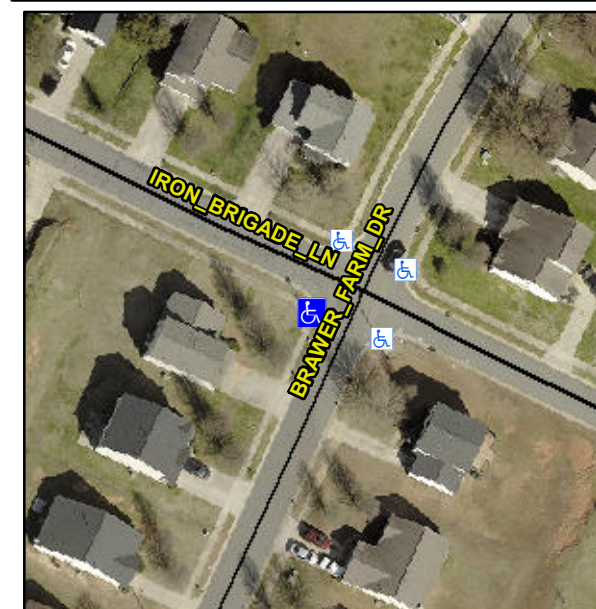
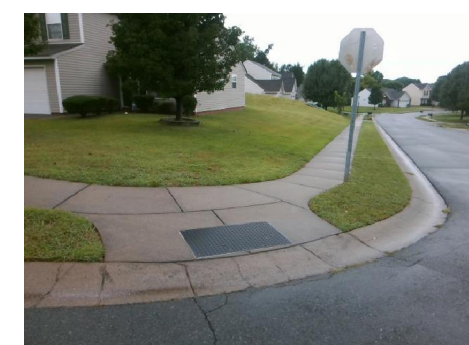
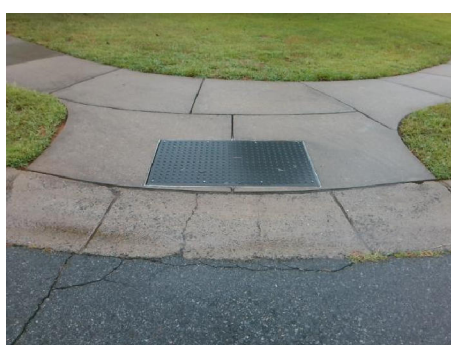
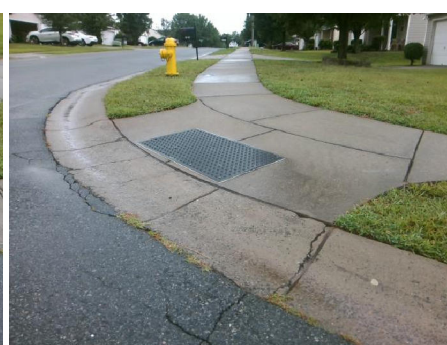
Not Found, R304.5.1, R304.2.2, R304.5.3

Compliance	Description	Data	Compliance	Description	Data
N/A	Ramp Length (in)	47.5	No	Ramp Slope (%)	9.4
No	Ramp Width (in)	46.0	No	Ramp XSlope (%)	6.9
N/A	Flare Type LT	N/A	N/A	Flare Type RT	N/A
N/A	Flare Slope LT (%)	N/A	N/A	Flare Slope RT (%)	N/A
N/A	Flare Traversable LT?	N/A	N/A	Flare Traversable RT?	N/A
N/A	Landing Length (in)	N/A	N/A	DWS Provided?	N/A
N/A	Landing Width (in)	N/A	N/A	DWS Contrast?	N/A
N/A	Landing Slope (%)	N/A	N/A	DWS Length (in)	N/A
N/A	Landing X Slope (%)	N/A	N/A	DWS Full Width?	N/A
N/A	Landing Curb? (Y/N)	N/A	N/A	DWS Offset (in)	N/A
N/A	Shared Landing?	N/A			
N/A	Gutter Ponding?	N/A	N/A	Gutter Slope (%)	N/A
N/A	Gutter Lip Ht (in)	N/A	N/A	Gutter X Slope (%)	N/A
N/A	Painted X Walk1?	No	N/A	Painted X Walk2?	No
	X Walk 1 Direction	To SE		X Walk 2 Direction	To NE
N/A	X Walk 1 Width (in)	N/A	N/A	X Walk 2 Width (in)	N/A
	X Walk 1 Slope (%)	6.9		X Walk 2 Slope (%)	0.0
	X Walk 1 X Slope (%)	1.6		X Walk 2 X Slope (%)	6.6

N/A	Ramp inside XWalk1?	N/A	N/A	Ramp inside XWalk2?	N/A
	Road Slope (%)	3.3	N/A	Clear Space?	N/A
	Road X Slope (%)	6.3	N/A	Clear Space to XWalk (in)	N/A
N/A	Any Obstructions?	N/A	N/A	Storm Grate/Utility Hazard?	N/A
	Obstruction Type			Storm Grate/Utility Type	
		N/A			N/A
			Yes	Surface Condition? (G/P)	Good

Remove & Replace Curb Ramp With Two New Directional Ramps or Equivalent.
