# Access Compliance Report

## Public Rights-of-Way

### (Curb Ramps)

Intersection ID: 10541	Main Street: CANTON_PL	Cross Street: POLK_ST	Location: W
ADA ID: DD8DAE55EA73	Ramp Type: Perp	Initial Pass/Fail: Fail	Overall Compliance: No
Severity Score: 33.75			
Codes/Mitigation Info/Possible Solution		Field Measurements/Component Compliance

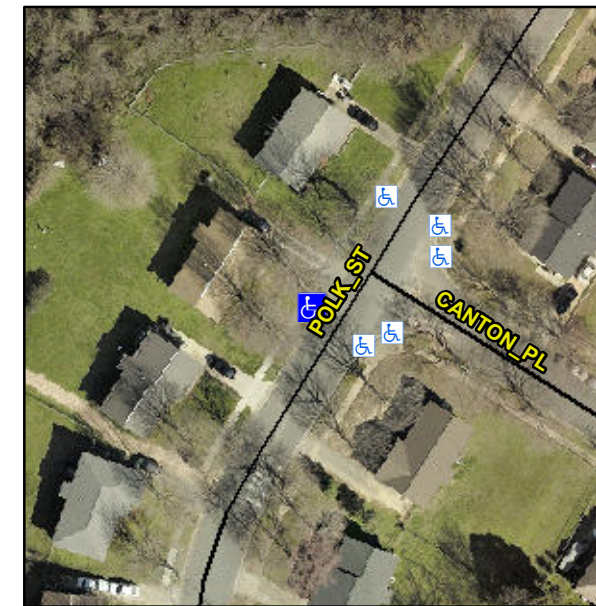
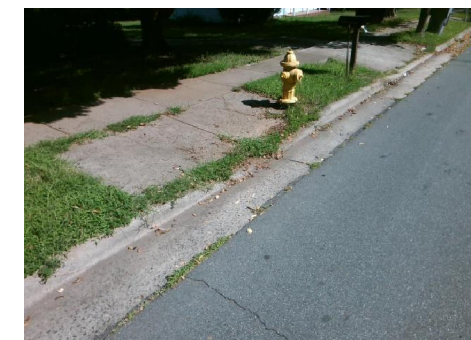
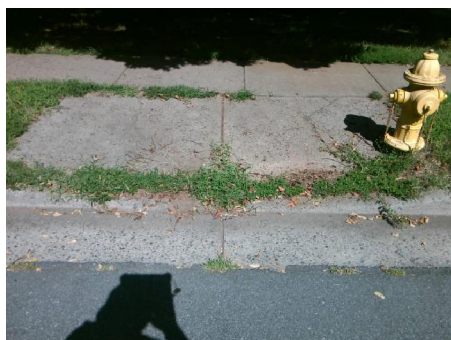
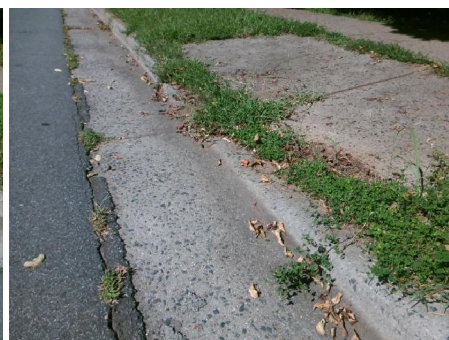
**Not Found, R304.5.1, R304.2.2, R304.5.3**

Compliance	Description	Data	Compliance	Description	Data
N/A	Ramp Length (in)	63.5	No	Ramp Slope (%)	8.9
No	Ramp Width (in)	47.0	No	Ramp XSlope (%)	6.9
N/A	Flare Type LT	N/A	N/A	Flare Type RT	N/A
N/A	Flare Slope LT (%)	N/A	N/A	Flare Slope RT (%)	N/A
N/A	Flare Traversable LT?	N/A	N/A	Flare Traversable RT?	N/A
N/A	Landing Length (in)	N/A	N/A	DWS Provided?	N/A
N/A	Landing Width (in)	N/A	N/A	DWS Contrast?	N/A
N/A	Landing Slope (%)	N/A	N/A	DWS Length (in)	N/A
N/A	Landing X Slope (%)	N/A	N/A	DWS Full Width?	N/A
N/A	Landing Curb? (Y/N)	N/A	N/A	DWS Offset (in)	N/A
N/A	Shared Landing?	N/A			
N/A	Gutter Ponding?	N/A	N/A	Gutter Slope (%)	N/A
N/A	Gutter Lip Ht (in)	0.5	N/A	Gutter X Slope (%)	N/A
N/A	Painted X Walk1?	No	N/A	Painted X Walk2?	N/A
	X Walk 1 Direction	To SE		X Walk 2 Direction	N/A
N/A	X Walk 1 Width (in)	N/A	N/A	X Walk 2 Width (in)	N/A
	X Walk 1 Slope (%)	3.0		X Walk 2 Slope (%)	N/A
	X Walk 1 X Slope (%)	4.9		X Walk 2 X Slope (%)	N/A

N/A	Ramp inside XWalk1?	N/A	N/A	Ramp inside XWalk2?	N/A
	Road Slope (%)	N/A	N/A	Clear Space?	N/A
	Road X Slope (%)	N/A	N/A	Clear Space to XWalk (in)	N/A
N/A	Any Obstructions?	N/A	N/A	Storm Grate/Utility Hazard?	N/A
	Obstruction Type			Storm Grate/Utility Type	
		N/A			N/A
			Yes	Surface Condition? (G/P)	Good

**Remove & Replace Entire Ramp.**

Total Cost: \$ 1850.00
