## **Access Compliance Report Public Rights-of-Way** (Curb Ramps)

Intersection ID: 10018981 Main Street: DEVONGATE LN Cross Street: DEVONGATE LN Location: NE **Overall Compliance: No Severity Score:** ADA ID: DD92E0CBB7AD Ramp Type: BlendTrans1 Initial Pass/Fail: Fail 8.75

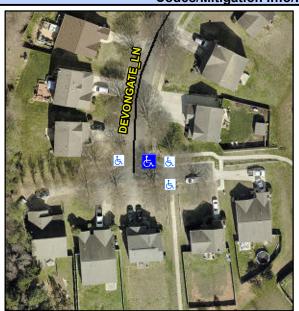
**DEVONGATE LN** Street 1 Name Stop Condition-Street 1 None N/A Street 2 Name Stop Condition-Street 2 N/A Possible Solutions: Remove & Replace Curb Ramp With Two New Directional Ramps or Equivalent. Surveyor Notes: N/A PROW/ADA: Not Found, R304.5.1

Ramp Length (in) Yes N/A 71.0 BlendTrans Slope (%) 40.0 Yes No Ramp Width (in) BlendTrans XSlope (%) N/A N/A Flare Type LT N/A Flare Type RT Flare Slope LT (%) N/A N/A Flare Slope RT (%) Flare Traversable LT? N/A N/A Flare Traversable RT? Landing Length (in) N/A N/A **DWS Provided?** Landing Width (in) N/A N/A **DWS Contrast?** N/A N/A Landing Slope (%) DWS Length (in) Landing X Slope (%) N/A N/A DWS Full Width? Landing Curb? (Y/N) N/A N/A DWS Offset (in) N/A Shared Landing? **Gutter Ponding?** N/A N/A Gutter Slope (%) Gutter Lip Ht (in) N/A N/A Gutter X Slope (%) Painted X Walk1? No N/A Painted X Walk2? X Walk 1 Direction To W X Walk 2 Direction N/A X Walk 1 Width (in) X Walk 2 Width (in) X Walk 1 Slope (%) 0.8 X Walk 2 Slope (%) X Walk 1 X Slope (%) 1.0 X Walk 2 X Slope (%) N/A N/A Ramp inside XWalk2? Ramp inside XWalk1? Road Slope (%) 1.0 Clear Space? N/A Road X Slope (%) 0.8 Clear Space to XWalk (in) N/A N/A Any Obstructions? Storm Grate/Utility Hazard? Obstruction Type Storm Grate/Utility Type N/A Yes Surface Condition? (G/P)
