Access Compliance Report

Public Rights-of-Way

(Curb Ramps)

Intersection ID: 24485	Main Street: CAMAROSS_DR	Cross Street: SAINTFIELD_PL	Location: NW
ADA ID: DDA23E825517	Ramp Type: Perp	Initial Pass/Fail: Fail	Overall Compliance: No
Severity Score: 8.75			
Codes/Mitigation Info/Possible Solution		Field Measurements/Component Compliance

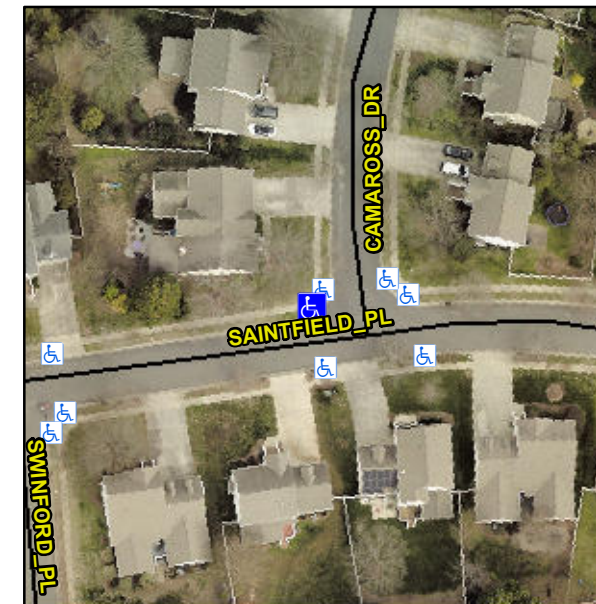
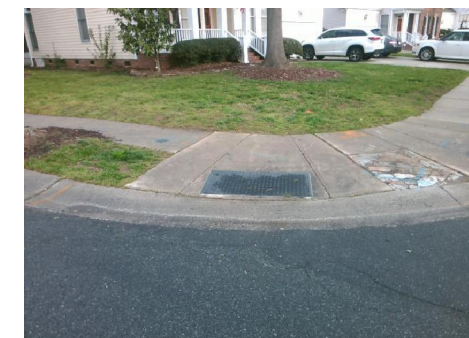
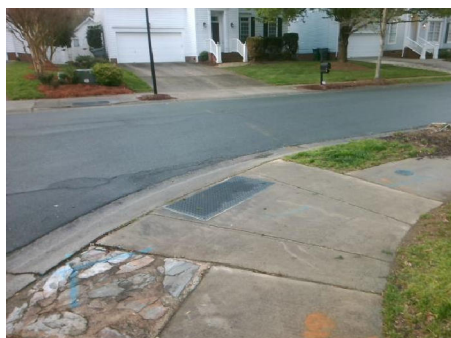
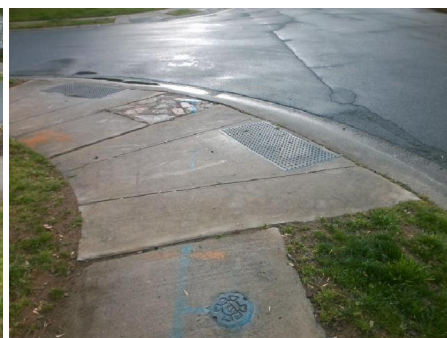
Not Found, R304.5.1

Compliance	Description	Data	Compliance	Description	Data
N/A	Ramp Length (in)	45.0	Yes	Ramp Slope (%)	6.7
No	Ramp Width (in)	45.5	Yes	Ramp XSlope (%)	1.5
N/A	Flare Type LT	N/A	N/A	Flare Type RT	N/A
N/A	Flare Slope LT (%)	N/A	N/A	Flare Slope RT (%)	N/A
N/A	Flare Traversable LT?	N/A	N/A	Flare Traversable RT?	N/A
N/A	Landing Length (in)	N/A	N/A	DWS Provided?	N/A
N/A	Landing Width (in)	N/A	N/A	DWS Contrast?	N/A
N/A	Landing Slope (%)	N/A	N/A	DWS Length (in)	N/A
N/A	Landing X Slope (%)	N/A	N/A	DWS Full Width?	N/A
N/A	Landing Curb? (Y/N)	N/A	N/A	DWS Offset (in)	N/A
N/A	Shared Landing?	N/A			
N/A	Gutter Ponding?	N/A	N/A	Gutter Slope (%)	N/A
N/A	Gutter Lip Ht (in)	N/A	N/A	Gutter X Slope (%)	N/A
N/A	Painted X Walk1?	No	N/A	Painted X Walk2?	N/A
	X Walk 1 Direction	To S		X Walk 2 Direction	N/A
N/A	X Walk 1 Width (in)	N/A	N/A	X Walk 2 Width (in)	N/A
	X Walk 1 Slope (%)	3.2		X Walk 2 Slope (%)	N/A
	X Walk 1 X Slope (%)	0.7		X Walk 2 X Slope (%)	N/A

N/A	Ramp inside XWalk1?	N/A	N/A	Ramp inside XWalk2?	N/A
	Road Slope (%)	N/A	N/A	Clear Space?	N/A
	Road X Slope (%)	N/A	N/A	Clear Space to XWalk (in)	N/A
N/A	Any Obstructions?	N/A	N/A	Storm Grate/Utility Hazard?	N/A
	Obstruction Type			Storm Grate/Utility Type	
		N/A			N/A
			Yes	Surface Condition? (G/P)	Good

Remove & Replace Entire Ramp.

Total Cost: \$ 1850.00
