Access Compliance Report

Public Rights-of-Way

(Curb Ramps)

Intersection ID: 11841	Main Street: E_18TH_ST	Cross Street: HARRILL_ST	Location:	N
ADA ID: DDBE35EFFE2D	Ramp Type: Directional1	Initial Pass/Fail: Pass	Overall Compliance: No	Severity Score: 0

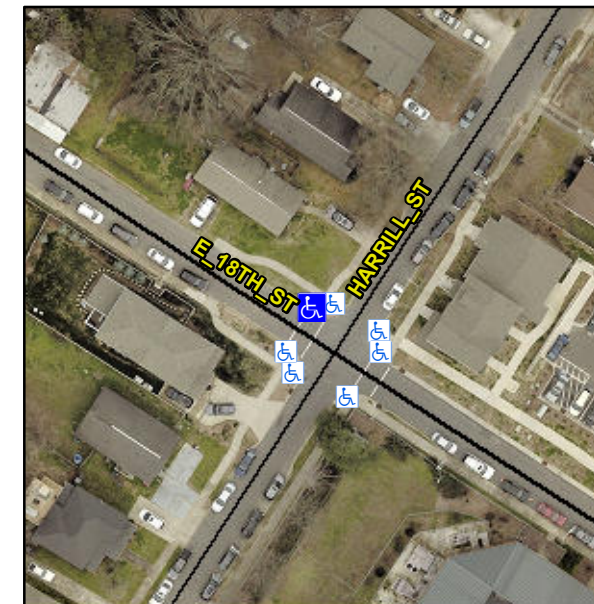
RP SL < 5%

Not Found, R304.5.3, R302.7

Compliance	Description	Data	Compliance	Description	Data
N/A	Ramp Length (in)	74.0	Yes	Grade Break?	Yes
Yes	Ramp Width (in)	57.5	No	Grade Break Slope (%)	5.5
Yes	Ramp Slope (%)	4.2	Yes	Grade Break XSlope (%)	0.9
Yes	Ramp XSlope (%)	0.6			
Yes	Flare Type LT	N/A	Yes	Flare Type RT	N/A
N/A	Flare Slope LT (%)	N/A	N/A	Flare Slope RT (%)	N/A
N/A	Flare Traversable LT?	No	N/A	Flare Traversable RT?	No
Yes	Landing Length (in)	58.5	Yes	DWS Provided?	Yes
Yes	Landing Width (in)	58.5	Yes	DWS Contrast?	Yes
Yes	Landing Slope (%)	0.9	Yes	DWS Length (in)	24.0
Yes	Landing X Slope (%)	0.2	Yes	DWS Full Width?	Yes
N/A	Landing Curb? (Y/N)	No	Yes	DWS Offset LT (in)	20.0
N/A	Shared Landing?	Yes	Yes	DWS Offset RT (in)	1.0
No	Gutter Ponding?	Yes	Yes	Gutter Slope (%)	1.7
Yes	Gutter Lip Ht (in)	0.0	Yes	Gutter X Slope (%)	1.9
N/A	Painted X Walk1?	No		Road Slope (%)	1.7
	X Walk 1 Direction	To SW		Road X Slope (%)	1.9
	X Walk 1 Width (in)	N/A		Clear Space?	Yes

X Walk 1 Slope (%)	1.7	N/A	Clear Space to XWalk (in)	N/A
	X Walk 1 X Slope (%)	1.9	Yes	Storm Grate/Utility Hazard?	No
N/A	Ramp inside XWalk1?	N/A		Storm Grate/Utility Type	
Yes	Any Obstructions?	No			N/A
	Obstruction Type		Yes	Surface Condition? (G/P)	Good
			N/A	Curb Slope (%)	16.0

Remove & Replace Entire Ramp.
