# Access Compliance Report

## Public Rights-of-Way

### (Curb Ramps)

Intersection ID: 30467	Main Street: PLANTERS_ROW_DR	Cross Street: SPRING_FROST_CT	Location: SE
ADA ID: DDBF9F5B7B1B	Ramp Type: PerpDiag	Initial Pass/Fail: Fail	Overall Compliance: No
Severity Score: 10			
Codes/Mitigation Info/Possible Solution		Field Measurements/Component Compliance

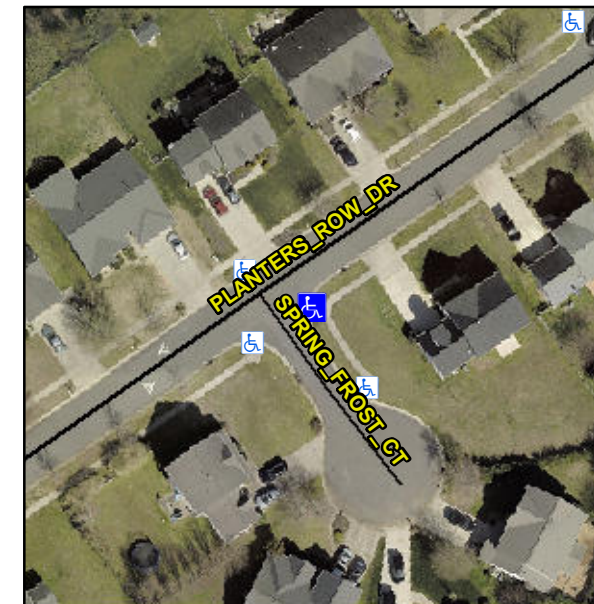
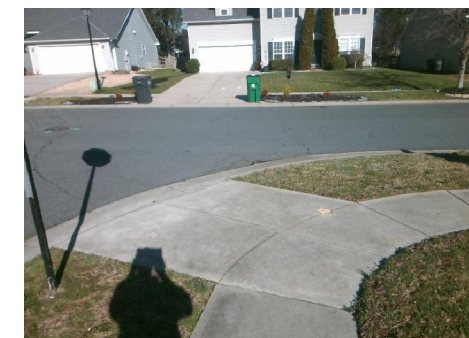
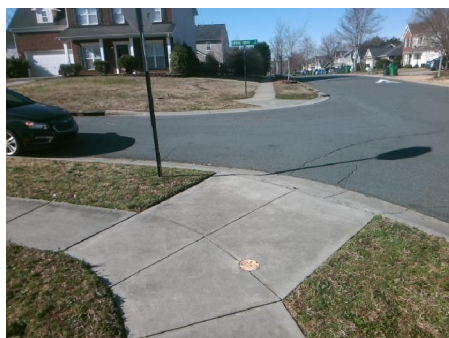
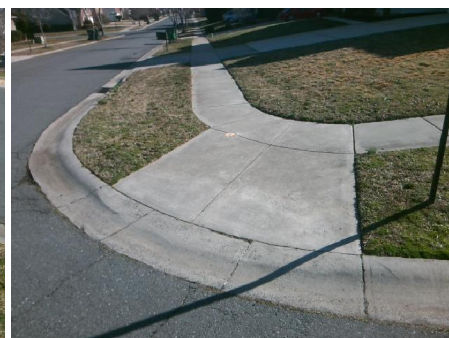
Compliance	Description	Data	Compliance	Description	Data
N/A	Ramp Length (in)	84.0	Yes	Ramp Slope (%)	5.8
No	Ramp Width (in)	46.0	No	Ramp XSlope (%)	3.4
N/A	Flare Type LT	N/A	N/A	Flare Type RT	N/A
N/A	Flare Slope LT (%)	N/A	N/A	Flare Slope RT (%)	N/A
N/A	Flare Traversable LT?	N/A	N/A	Flare Traversable RT?	N/A
N/A	Landing Length (in)	N/A	N/A	DWS Provided?	N/A
N/A	Landing Width (in)	N/A	N/A	DWS Contrast?	N/A
N/A	Landing Slope (%)	N/A	N/A	DWS Length (in)	N/A
N/A	Landing X Slope (%)	N/A	N/A	DWS Full Width?	N/A
N/A	Landing Curb? (Y/N)	N/A	N/A	DWS Offset (in)	N/A
N/A	Shared Landing?	N/A			
N/A	Gutter Ponding?	N/A	N/A	Gutter Slope (%)	N/A
N/A	Gutter Lip Ht (in)	N/A	N/A	Gutter X Slope (%)	N/A
N/A	Painted X Walk1?	No	N/A	Painted X Walk2?	No
	X Walk 1 Direction	To NW		X Walk 2 Direction	To SW
N/A	X Walk 1 Width (in)	N/A	N/A	X Walk 2 Width (in)	N/A
	X Walk 1 Slope (%)	4.6		X Walk 2 Slope (%)	6.1
	X Walk 1 X Slope (%)	5.3		X Walk 2 X Slope (%)	0.6

N/A	Ramp inside XWalk1?	N/A	N/A	Ramp inside XWalk2?	N/A
	Road Slope (%)	1.3	N/A	Clear Space?	N/A
	Road X Slope (%)	5.8	N/A	Clear Space to XWalk (in)	N/A
N/A	Any Obstructions?	N/A	N/A	Storm Grate/Utility Hazard?	N/A
	Obstruction Type			Storm Grate/Utility Type	
		N/A			N/A
			Yes	Surface Condition? (G/P)	Good

**Remove & Replace Curb Ramp With Two New Directional Ramps or Equivalent.**

**R304.5.1, R304.5.3**
