Access Compliance Report

Public Rights-of-Way

(Curb Ramps)

Intersection ID: 17138	Main Street: IDLEWILD_RD	Cross Street: PINEY GROVE RD	Location: E
ADA ID: DDC9A710DFB8	Ramp Type: BlendTrans2	Initial Pass/Fail: Fail	Overall Compliance: No
Severity Score: 8.75			
Codes/Mitigation Info/Possible Solution		Field Measurements/Component Compliance

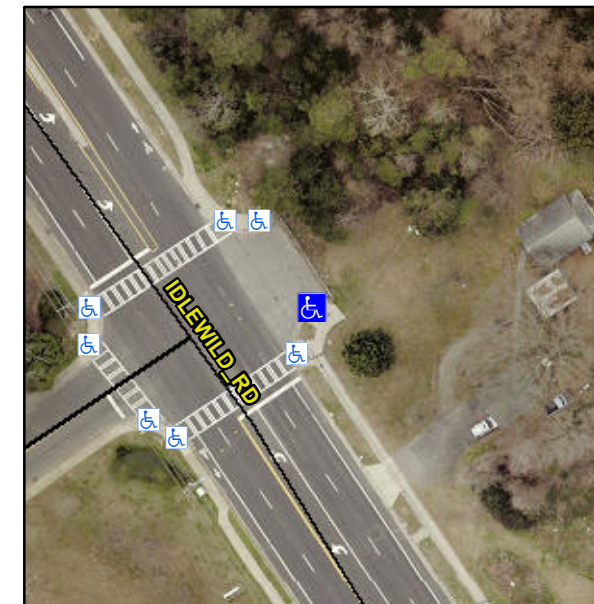
Not Found, R304.5.1

Compliance	Description	Data	Compliance	Description	Data
N/A	Ramp Length (in)	168.0	Yes	BlendTrans Slope (%)	2.4
No	Ramp Width (in)	44.0	Yes	BlendTrans XSlope (%)	0.2
N/A	Flare Type LT	N/A	N/A	Flare Type RT	N/A
N/A	Flare Slope LT (%)	N/A	N/A	Flare Slope RT (%)	N/A
N/A	Flare Traversable LT?	N/A	N/A	Flare Traversable RT?	N/A
N/A	Landing Length (in)	N/A	N/A	DWS Provided?	N/A
N/A	Landing Width (in)	N/A	N/A	DWS Contrast?	N/A
N/A	Landing Slope (%)	N/A	N/A	DWS Length (in)	N/A
N/A	Landing X Slope (%)	N/A	N/A	DWS Full Width?	N/A
N/A	Landing Curb? (Y/N)	N/A	N/A	DWS Offset (in)	N/A
N/A	Shared Landing?	N/A			
N/A	Gutter Ponding?	N/A	N/A	Gutter Slope (%)	N/A
N/A	Gutter Lip Ht (in)	N/A	N/A	Gutter X Slope (%)	N/A
N/A	Painted X Walk1?	No	N/A	Painted X Walk2?	N/A
	X Walk 1 Direction	To NW		X Walk 2 Direction	N/A
	X Walk 1 Width (in)	N/A		X Walk 2 Width (in)	N/A
	X Walk 1 Slope (%)	2.9		X Walk 2 Slope (%)	N/A
	X Walk 1 X Slope (%)	0.2		X Walk 2 X Slope (%)	N/A

N/A	Ramp inside XWalk1?	N/A	N/A	Ramp inside XWalk2?	N/A
	Road Slope (%)	0.2		Clear Space?	N/A
	Road X Slope (%)	2.9	N/A	Clear Space to XWalk (in)	N/A
N/A	Any Obstructions?	N/A	N/A	Storm Grate/Utility Hazard?	N/A
	Obstruction Type			Storm Grate/Utility Type	
		N/A			N/A
			Yes	Surface Condition? (G/P)	Good
			No	Curb Slope (%)	6.6

Remove & Replace Curb Ramp With Two New Directional Ramps or Equivalent.
