# Access Compliance Report

## Public Rights-of-Way

### (Curb Ramps)

| Intersection ID: 12493 | Main Street: BELVEDERE_AV | Cross Street: WINTER_ST | Location: NE |

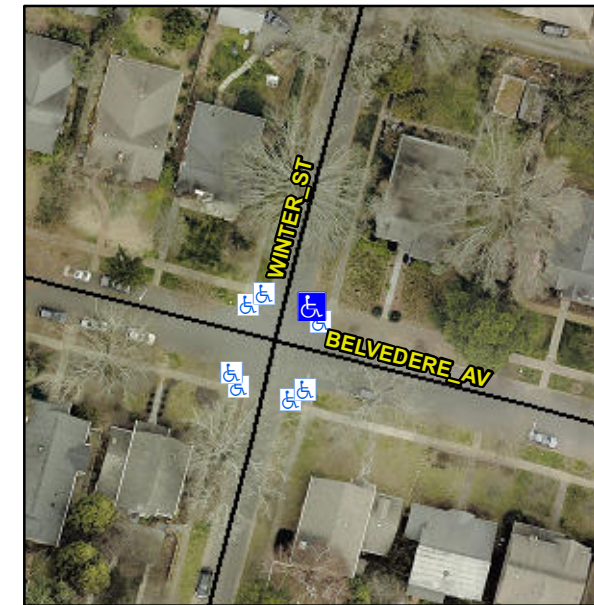
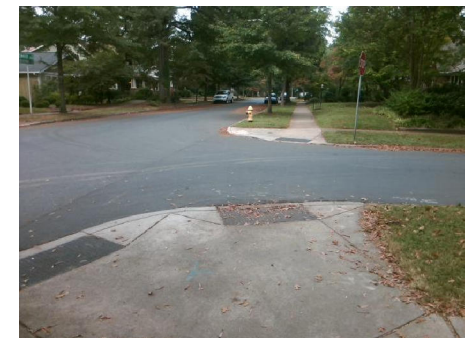
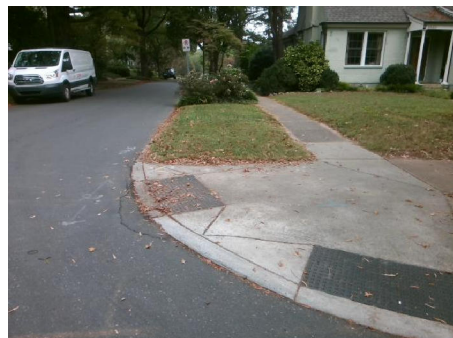
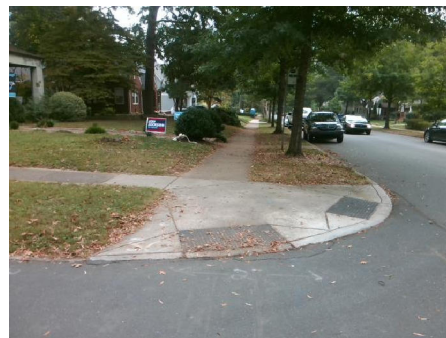
**R304.2.2-Perp, R304.3.2-Para,  
R304.5.3**

| Compliance | Description | Data | Compliance | Description | Data |
|---|---|---|---|---|---|
| No | Landing Slope (%) | 2.3 | Yes | DWS Length (in) | 24.0 |
| No | Landing X Slope (%) | 2.2 | Yes | DWS Full Width? | Yes |
| Yes | Gutter Lip Ht (in) | 0.0 | No | Gutter X Slope (%) | 5.0 |

**Remove & Replace Landing.  
Remove & Replace Gutter.**
