Access Compliance Report

Public Rights-of-Way

(Curb Ramps)

Intersection ID: 46500	Main Street: NEWBRIDGE_RD	Cross Street: ROCK_ISLAND_RD	Location: NE
ADA ID: DDD0EFD67B93	Ramp Type: PerpDiag	Initial Pass/Fail: Fail	Overall Compliance: No
Severity Score: 22.5			
Codes/Mitigation Info/Possible Solution		Field Measurements/Component Compliance

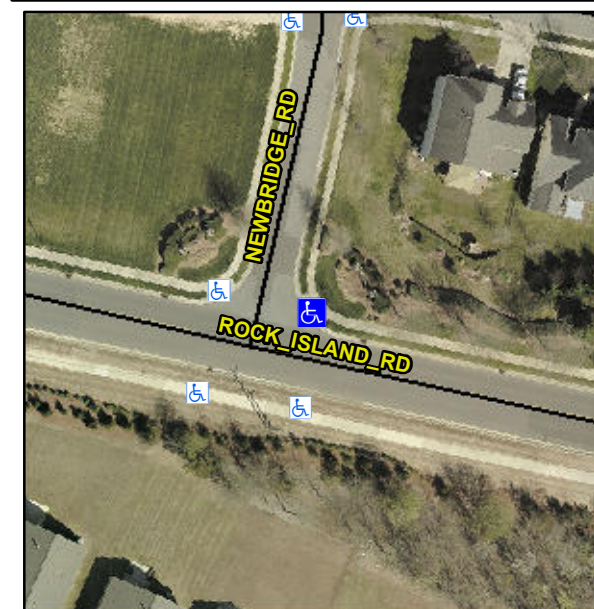
Not Found, R304.5.1, R304.2.2, R304.5.3

Compliance	Description	Data	Compliance	Description	Data
N/A	Ramp Length (in)	47.0	No	Ramp Slope (%)	9.2
No	Ramp Width (in)	46.0	No	Ramp XSlope (%)	4.3
N/A	Flare Type LT	N/A	N/A	Flare Type RT	N/A
N/A	Flare Slope LT (%)	N/A	N/A	Flare Slope RT (%)	N/A
N/A	Flare Traversable LT?	N/A	N/A	Flare Traversable RT?	N/A
N/A	Landing Length (in)	N/A	N/A	DWS Provided?	N/A
N/A	Landing Width (in)	N/A	N/A	DWS Contrast?	N/A
N/A	Landing Slope (%)	N/A	N/A	DWS Length (in)	N/A
N/A	Landing X Slope (%)	N/A	N/A	DWS Full Width?	N/A
N/A	Landing Curb? (Y/N)	N/A	N/A	DWS Offset (in)	N/A
N/A	Shared Landing?	N/A			
N/A	Gutter Ponding?	N/A	N/A	Gutter Slope (%)	N/A
N/A	Gutter Lip Ht (in)	N/A	N/A	Gutter X Slope (%)	N/A
N/A	Painted X Walk1?	No	N/A	Painted X Walk2?	No
	X Walk 1 Direction	To NW		X Walk 2 Direction	To SW
N/A	X Walk 1 Width (in)	N/A	N/A	X Walk 2 Width (in)	N/A
	X Walk 1 Slope (%)	0.9		X Walk 2 Slope (%)	0.2
	X Walk 1 X Slope (%)	2.3		X Walk 2 X Slope (%)	2.0

N/A	Ramp inside XWalk1?	N/A	N/A	Ramp inside XWalk2?	N/A
	Road Slope (%)	1.8	N/A	Clear Space?	N/A
	Road X Slope (%)	2.2	N/A	Clear Space to XWalk (in)	N/A
N/A	Any Obstructions?	N/A	N/A	Storm Grate/Utility Hazard?	N/A
	Obstruction Type			Storm Grate/Utility Type	
		N/A			N/A
			Yes	Surface Condition? (G/P)	Good

Possible Solutions:

Remove & Replace Curb Ramp With Two New Directional Ramps or Equivalent.
