Access Compliance Report Public Rights-of-Way (Curb Ramps)

Intersection ID: 6121 Main Street: AMHERST_GLEN_DR Cross Street: ATKINS_RIDGE_DR Location: E

ADA ID: DDE3D64C2D5D Ramp Type: PerpDiag Initial Pass/Fail: Fail Overall Compliance: No Severity Score: 21.25

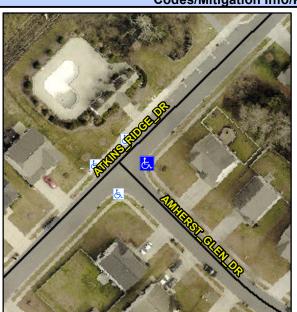
ATKINS RIDGE DR StopSign AMHERST GLEN DR None Possible Solutions:

Not Found, R304.5.1, R304.2.2

| Field Measurements/Component Compliance | | | | | | |
|---|---|---|---|---|---|---|
| | N/A | Ramp Length (in) | 48.0 | No | Ramp Slope (%) | 8.7 |
| | No | Ramp Width (in) | 47.0 | Yes | Ramp XSlope (%) | 0.1 |

Remove & Replace Curb Ramp With
Two New Directional Ramps or
Equivalent.
