# Access Compliance Report

## Public Rights-of-Way

### (Curb Ramps)

| Intersection ID: N/A | Main Street: NATIONAL_AV | Cross Street: POTOMAC_RIVER_PY | Location: W |

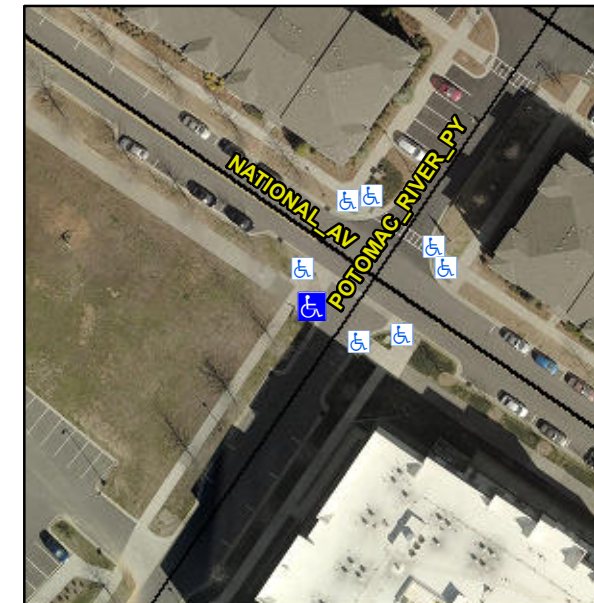
| ADA ID: DDE9AA86DDD7 | Ramp Type: Directional1 | Initial Pass/Fail: Fail | Overall Compliance: No |

**R304.5.3**

| Compliance | Description | Data | Compliance | Description | Data |
|---|---|---|---|---|---|
| No | Ramp XSlope (%) | 4.9 | | | |

**Remove & Replace Entire Ramp.**
