Access Compliance Report Public Rights-of-Way (Curb Ramps)

Intersection ID: 18558 Main Street: KIRKPATRICK_RD Cross Street: NOTTINGHAM_DR Location: E

ADA ID: DDF1CC9F9D0E Ramp Type: Perp Initial Pass/Fail: Fail Overall Compliance: No Severity Score: 21.25

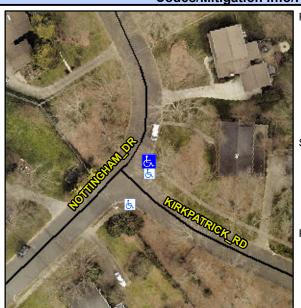
Not Found, R304.5.1, R304.5.3

Compliance Description Data Compliance Description Data Yes N/A Ramp Length (in) 52.0 Ramp Slope (%) 6.5 No Ramp XSlope (%) No Ramp Width (in) 47.0 5.3 N/A Flare Type LT N/A N/A Flare Type RT N/A N/A N/A Flare Slope RT (%) N/A Flare Slope LT (%) N/A N/A Flare Traversable LT? N/A N/A Flare Traversable RT? N/A N/A N/A N/A DWS Provided? N/A Landing Length (in) N/A Landing Width (in) N/A N/A **DWS Contrast?** N/A N/A N/A N/A Landing Slope (%) DWS Length (in) N/A N/A Landing X Slope (%) N/A N/A DWS Full Width? N/A N/A Landing Curb? (Y/N) N/A N/A DWS Offset (in) N/A N/A N/A Shared Landing? N/A **Gutter Ponding?** N/A N/A Gutter Slope (%) N/A N/A Gutter Lip Ht (in) N/A N/A Gutter X Slope (%) N/A N/A Painted X Walk1? No N/A Painted X Walk2? N/A X Walk 1 Direction To NW X Walk 2 Direction N/A N/A N/A X Walk 1 Width (in) X Walk 2 Width (in) N/A X Walk 1 Slope (%) 2.8 X Walk 2 Slope (%) N/A X Walk 2 X Slope (%) X Walk 1 X Slope (%) 1.0 N/A N/A N/A N/A Ramp inside XWalk1? Ramp inside XWalk2? N/A Road Slope (%) N/A N/A Clear Space? N/A Road X Slope (%) N/A N/A Clear Space to XWalk (in) N/A N/A N/A Any Obstructions? N/A Storm Grate/Utility Hazard? N/A **Obstruction Type** Storm Grate/Utility Type N/A N/A

Remove & Replace Entire Ramp.
