# Access Compliance Report

## Public Rights-of-Way

### (Curb Ramps)

| Intersection ID: 3786 | Main Street: GALLOWAY_RD | Cross Street: MALLARD_CREEK_RD | Location: W |

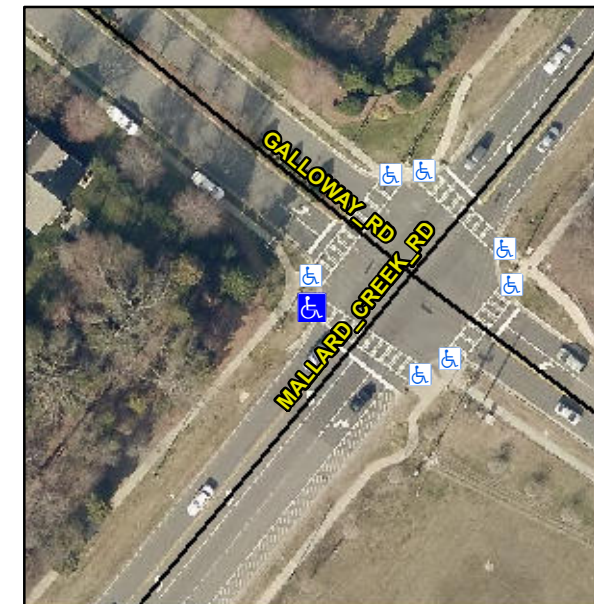
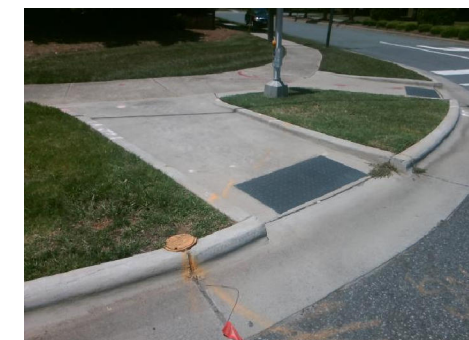
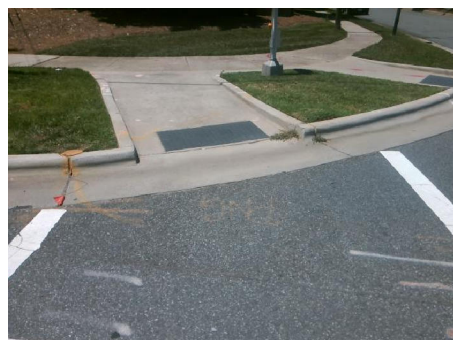
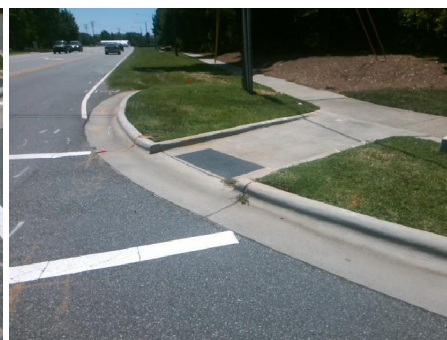
| ADA ID: DDF28F6B7557 | Ramp Type: Perp | Initial Pass/Fail: Fail | Overall Compliance: No |
| Severity Score: 12.5 | | | |

**R304.2.2**

| Compliance | Description | Data | Compliance | Description | Data |
|---|---|---|---|---|---|
| N/A | Ramp Length (in) | 153.0 | No | Ramp Slope (%) | 10.4 |
| Yes | Ramp Width (in) | 70.0 | Yes | Ramp XSlope (%) | 1.2 |

**Remove & Replace Entire Ramp.**

**\$ 1850.00**
