# Access Compliance Report

## Public Rights-of-Way

| Intersection ID: 43145 | Main Street: E_INDEPENDENCE_BV | Cross Street: E_INDEPENDENCE/BRIAR_CREEK_RA | Location: SW |
| ADA ID: DDFC8887102D | Ramp Type: IslandPerp | Initial Pass/Fail: Fail | Overall Compliance: No |

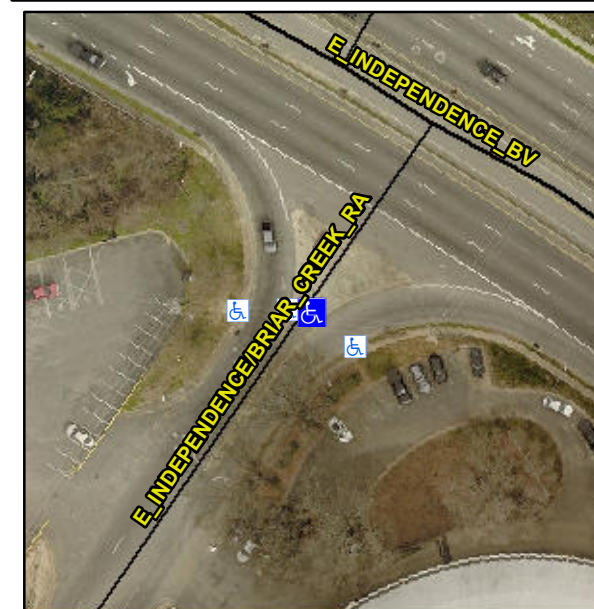
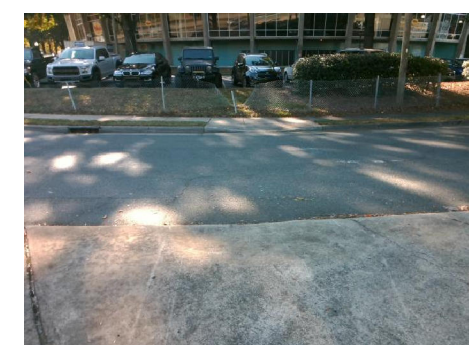
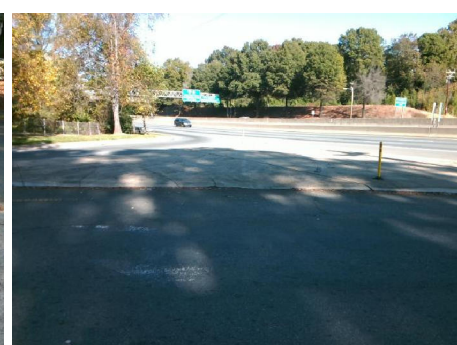
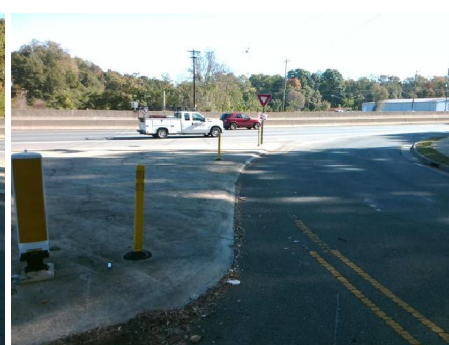
| Severity Score: 35 | | | |

**Not Found, R304.5.1, R304.2.2, R304.5.3**

| Compliance | Description | Data | Compliance | Description | Data |
|---|---|---|---|---|---|
| N/A | Ramp Length (in) | 35.0 | No | Ramp Slope (%) | 12.1 |
| No | Ramp Width (in) | 44.0 | No | Ramp XSlope (%) | 2.5 |

**Remove & Replace Entire Ramp.**

Total Cost: \$ 3400.00
