# Access Compliance Report

## Public Rights-of-Way

### (Curb Ramps)

Intersection ID: 10024743	Main Street: DEER RIDGE LN	Cross Street: N/A	Location: SE
ADA ID: DE14597CF05A	Ramp Type: PerpDiag	Initial Pass/Fail: Fail	Overall Compliance: No
		Severity Score: 25

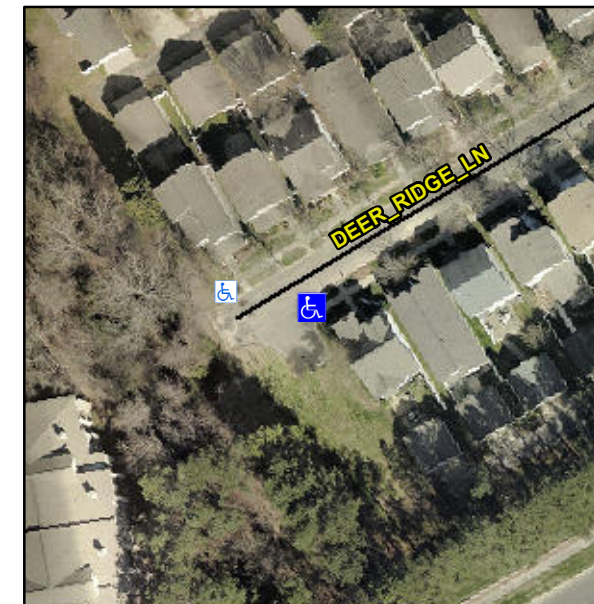
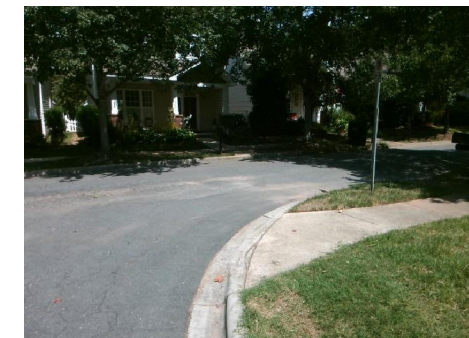
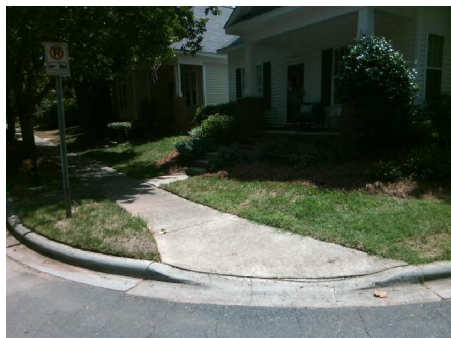
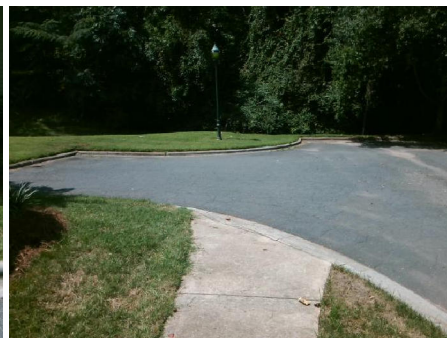
**Not Found, R304.2.2**

Compliance	Description	Data	Compliance	Description	Data
N/A	Ramp Length (in)	42.0	No	Ramp Slope (%)	12.7
Yes	Ramp Width (in)	53.0	Yes	Ramp XSlope (%)	1.6
N/A	Flare Type LT	N/A	N/A	Flare Type RT	N/A
N/A	Flare Slope LT (%)	N/A	N/A	Flare Slope RT (%)	N/A
N/A	Flare Traversable LT?	N/A	N/A	Flare Traversable RT?	N/A
N/A	Landing Length (in)	N/A	N/A	DWS Provided?	N/A
N/A	Landing Width (in)	N/A	N/A	DWS Contrast?	N/A
N/A	Landing Slope (%)	N/A	N/A	DWS Length (in)	N/A
N/A	Landing X Slope (%)	N/A	N/A	DWS Full Width?	N/A
N/A	Landing Curb? (Y/N)	N/A	N/A	DWS Offset (in)	N/A
N/A	Shared Landing?	N/A			
N/A	Gutter Ponding?	N/A	N/A	Gutter Slope (%)	N/A
N/A	Gutter Lip Ht (in)	N/A	N/A	Gutter X Slope (%)	N/A
N/A	Painted X Walk1?	No	N/A	Painted X Walk2?	No
	X Walk 1 Direction	To N		X Walk 2 Direction	To W
N/A	X Walk 1 Width (in)	N/A	N/A	X Walk 2 Width (in)	N/A
	X Walk 1 Slope (%)	2.4		X Walk 2 Slope (%)	1.4
	X Walk 1 X Slope (%)	2.7		X Walk 2 X Slope (%)	1.9

N/A	Ramp inside XWalk1?	N/A	N/A	Ramp inside XWalk2?	N/A
	Road Slope (%)	0.2	N/A	Clear Space?	N/A
	Road X Slope (%)	5.3	N/A	Clear Space to XWalk (in)	N/A
N/A	Any Obstructions?	N/A	N/A	Storm Grate/Utility Hazard?	N/A
	Obstruction Type			Storm Grate/Utility Type	
		N/A			N/A
			Yes	Surface Condition? (G/P)	Good

**Remove & Replace Curb Ramp With Two New Directional Ramps or Equivalent.**
