# Access Compliance Report

## Public Rights-of-Way

### (Curb Ramps)

Intersection ID: 27236	Main Street: BALLANTYNE CORPORATE PCross Street: BRIXHAM HILL AV	Location: NE
ADA ID: DE18ED7B7AC5	Ramp Type: Perp	Initial Pass/Fail: Fail
	Overall Compliance: No	Severity Score: 10
Codes/Mitigation Info/Possible Solution		Field Measurements/Component Compliance

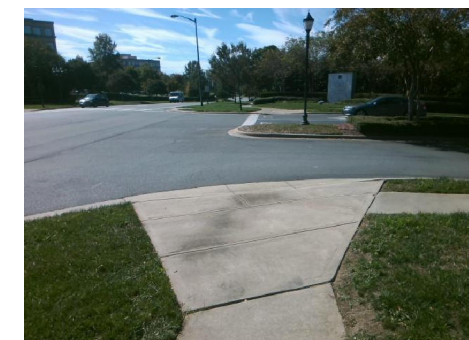
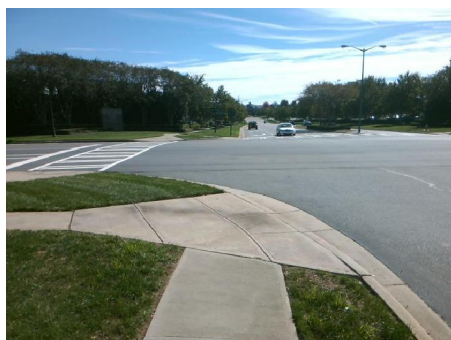
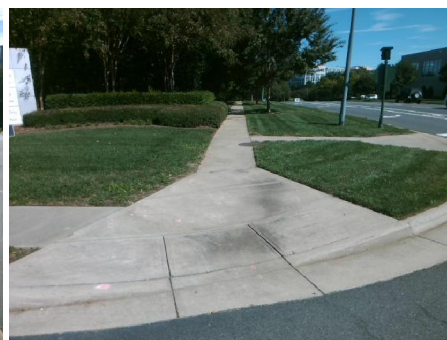
Compliance	Description	Data	Compliance	Description	Data
N/A	Ramp Length (in)	88.0	Yes	Ramp Slope (%)	5.6
No	Ramp Width (in)	44.0	No	Ramp XSlope (%)	4.1
N/A	Flare Type LT	N/A	N/A	Flare Type RT	N/A
N/A	Flare Slope LT (%)	N/A	N/A	Flare Slope RT (%)	N/A
N/A	Flare Traversable LT?	N/A	N/A	Flare Traversable RT?	N/A
N/A	Landing Length (in)	N/A	N/A	DWS Provided?	N/A
N/A	Landing Width (in)	N/A	N/A	DWS Contrast?	N/A
N/A	Landing Slope (%)	N/A	N/A	DWS Length (in)	N/A
N/A	Landing X Slope (%)	N/A	N/A	DWS Full Width?	N/A
N/A	Landing Curb? (Y/N)	N/A	N/A	DWS Offset (in)	N/A
N/A	Shared Landing?	N/A			
N/A	Gutter Ponding?	N/A	N/A	Gutter Slope (%)	N/A
N/A	Gutter Lip Ht (in)	N/A	N/A	Gutter X Slope (%)	N/A
N/A	Painted X Walk1?	No	N/A	Painted X Walk2?	N/A
	X Walk 1 Direction	To SW		X Walk 2 Direction	N/A
N/A	X Walk 1 Width (in)	N/A	N/A	X Walk 2 Width (in)	N/A
	X Walk 1 Slope (%)	0.4		X Walk 2 Slope (%)	N/A
	X Walk 1 X Slope (%)	0.1		X Walk 2 X Slope (%)	N/A

N/A	Ramp inside XWalk1?	N/A	N/A	Ramp inside XWalk2?	N/A
	Road Slope (%)	N/A	N/A	Clear Space?	N/A
	Road X Slope (%)	N/A	N/A	Clear Space to XWalk (in)	N/A
N/A	Any Obstructions?	N/A	N/A	Storm Grate/Utility Hazard?	N/A
	Obstruction Type			Storm Grate/Utility Type	
		N/A			N/A
			Yes	Surface Condition? (G/P)	Good

**Remove & Replace Entire Ramp.**

Total Cost: \$ 1850.00
