# Access Compliance Report

## Public Rights-of-Way

### (Curb Ramps)

Intersection ID: 20148	Main Street: CANNARTI_DR	Cross Street: CORNUS_LN	Location: NW
ADA ID: DE19FC52150E	Ramp Type: PerpDiag	Initial Pass/Fail: Fail	Overall Compliance: No
Severity Score: 22.5			
Codes/Mitigation Info/Possible Solution		Field Measurements/Component Compliance

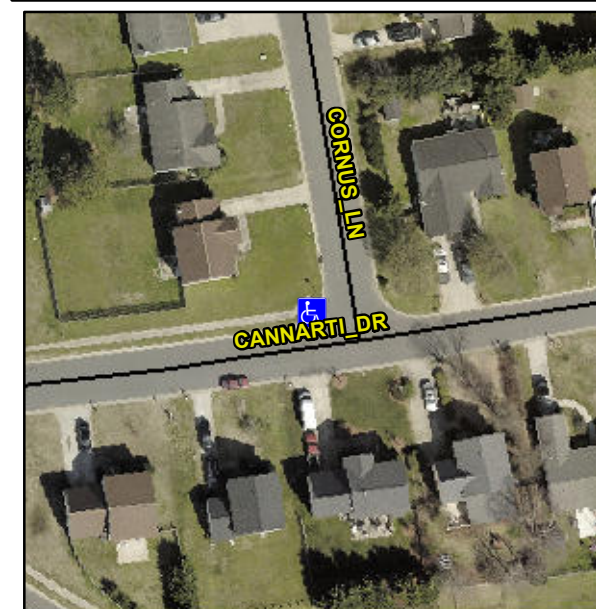
**Not Found, R304.5.1, R304.2.2, R304.5.3**

Compliance	Description	Data	Compliance	Description	Data
N/A	Ramp Length (in)	60.0	No	Ramp Slope (%)	9.5
No	Ramp Width (in)	39.5	No	Ramp XSlope (%)	2.9
N/A	Flare Type LT	N/A	N/A	Flare Type RT	N/A
N/A	Flare Slope LT (%)	N/A	N/A	Flare Slope RT (%)	N/A
N/A	Flare Traversable LT?	N/A	N/A	Flare Traversable RT?	N/A
N/A	Landing Length (in)	N/A	N/A	DWS Provided?	N/A
N/A	Landing Width (in)	N/A	N/A	DWS Contrast?	N/A
N/A	Landing Slope (%)	N/A	N/A	DWS Length (in)	N/A
N/A	Landing X Slope (%)	N/A	N/A	DWS Full Width?	N/A
N/A	Landing Curb? (Y/N)	N/A	N/A	DWS Offset (in)	N/A
N/A	Shared Landing?	N/A			
N/A	Gutter Ponding?	N/A	N/A	Gutter Slope (%)	N/A
N/A	Gutter Lip Ht (in)	N/A	N/A	Gutter X Slope (%)	N/A
N/A	Painted X Walk1?	No	N/A	Painted X Walk2?	No
	X Walk 1 Direction	To S		X Walk 2 Direction	To E
N/A	X Walk 1 Width (in)	N/A	N/A	X Walk 2 Width (in)	N/A
	X Walk 1 Slope (%)	3.5		X Walk 2 Slope (%)	0.2
	X Walk 1 X Slope (%)	0.9		X Walk 2 X Slope (%)	1.7

N/A	Ramp inside XWalk1?	N/A	N/A	Ramp inside XWalk2?	N/A
	Road Slope (%)	2.3	N/A	Clear Space?	N/A
	Road X Slope (%)	1.4	N/A	Clear Space to XWalk (in)	N/A
N/A	Any Obstructions?	N/A	N/A	Storm Grate/Utility Hazard?	N/A
	Obstruction Type			Storm Grate/Utility Type	
		N/A			N/A
		Yes		Surface Condition? (G/P)	Good

**Remove & Replace Curb Ramp With Two New Directional Ramps or Equivalent.**
