# Access Compliance Report

## Public Rights-of-Way

### (Curb Ramps)

Intersection ID: 51721	Main Street: PROVIDENCE_RD_WEST	Cross Street: BALLANCROFT_PY	Location: SE
ADA ID: DE1BF924FEB9	Ramp Type: Perp	Initial Pass/Fail: Fail	Overall Compliance: No
Severity Score: 1.25			
Codes/Mitigation Info/Possible Solution		Field Measurements/Component Compliance

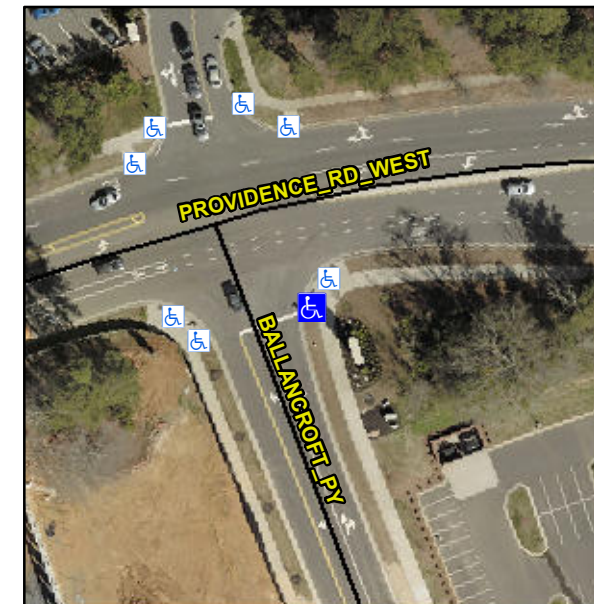
Compliance	Description	Data	Compliance	Description	Data
N/A	Ramp Length (in)	95.0	Yes	Ramp Slope (%)	7.8
Yes	Ramp Width (in)	48.0	No	Ramp XSlope (%)	2.3
N/A	Flare Type LT	N/A	N/A	Flare Type RT	N/A
N/A	Flare Slope LT (%)	N/A	N/A	Flare Slope RT (%)	N/A
N/A	Flare Traversable LT?	N/A	N/A	Flare Traversable RT?	N/A
N/A	Landing Length (in)	N/A	N/A	DWS Provided?	N/A
N/A	Landing Width (in)	N/A	N/A	DWS Contrast?	N/A
N/A	Landing Slope (%)	N/A	N/A	DWS Length (in)	N/A
N/A	Landing X Slope (%)	N/A	N/A	DWS Full Width?	N/A
N/A	Landing Curb? (Y/N)	N/A	N/A	DWS Offset (in)	N/A
N/A	Shared Landing?	N/A			
N/A	Gutter Ponding?	N/A	N/A	Gutter Slope (%)	N/A
N/A	Gutter Lip Ht (in)	N/A	N/A	Gutter X Slope (%)	N/A
N/A	Painted X Walk1?	No	N/A	Painted X Walk2?	N/A
	X Walk 1 Direction	To W		X Walk 2 Direction	N/A
N/A	X Walk 1 Width (in)	N/A	N/A	X Walk 2 Width (in)	N/A
	X Walk 1 Slope (%)	1.0		X Walk 2 Slope (%)	N/A
	X Walk 1 X Slope (%)	3.1		X Walk 2 X Slope (%)	N/A

N/A	Ramp inside XWalk1?	N/A	N/A	Ramp inside XWalk2?	N/A
	Road Slope (%)	N/A	N/A	Clear Space?	N/A
	Road X Slope (%)	N/A	N/A	Clear Space to XWalk (in)	N/A
N/A	Any Obstructions?	N/A	N/A	Storm Grate/Utility Hazard?	N/A
	Obstruction Type			Storm Grate/Utility Type	
		N/A			N/A
		Yes		Surface Condition? (G/P)	Good

**Remove & Replace Entire Ramp.**

**R304.5.3**

**\$ 1850.00**
