Access Compliance Report

Public Rights-of-Way

(Curb Ramps)

Intersection ID: 30577	Main Street: HAMILTON_GREEN_DR	Cross Street: STEELE_CREEK_RD	Location: SE
ADA ID: DE21B23C7EEE	Ramp Type: Perp	Initial Pass/Fail: Fail	Overall Compliance: No
Severity Score: 13.75			
Codes/Mitigation Info/Possible Solution		Field Measurements/Component Compliance

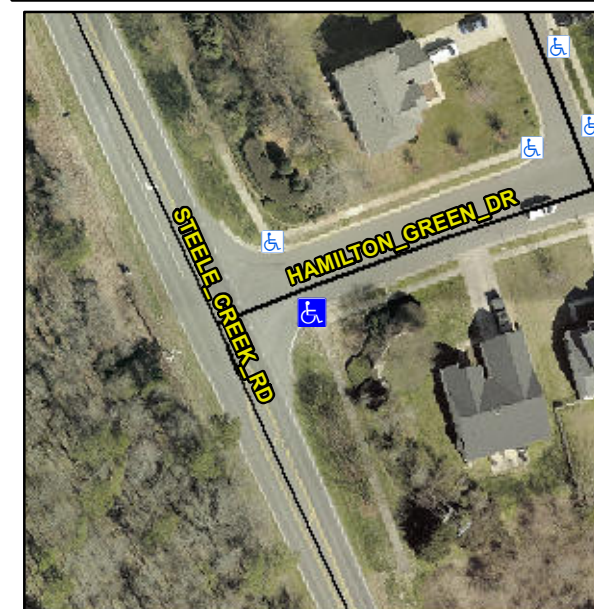
R304.2.2, R304.5.3

Compliance	Description	Data	Compliance	Description	Data
N/A	Ramp Length (in)	49.0	No	Ramp Slope (%)	10.2
Yes	Ramp Width (in)	48.0	No	Ramp XSlope (%)	4.3
N/A	Flare Type LT	N/A	N/A	Flare Type RT	N/A
N/A	Flare Slope LT (%)	N/A	N/A	Flare Slope RT (%)	N/A
N/A	Flare Traversable LT?	N/A	N/A	Flare Traversable RT?	N/A
N/A	Landing Length (in)	N/A	N/A	DWS Provided?	N/A
N/A	Landing Width (in)	N/A	N/A	DWS Contrast?	N/A
N/A	Landing Slope (%)	N/A	N/A	DWS Length (in)	N/A
N/A	Landing X Slope (%)	N/A	N/A	DWS Full Width?	N/A
N/A	Landing Curb? (Y/N)	N/A	N/A	DWS Offset (in)	N/A
N/A	Shared Landing?	N/A			
N/A	Gutter Ponding?	N/A	N/A	Gutter Slope (%)	N/A
N/A	Gutter Lip Ht (in)	N/A	N/A	Gutter X Slope (%)	N/A
N/A	Painted X Walk1?	No	N/A	Painted X Walk2?	N/A
	X Walk 1 Direction	To N		X Walk 2 Direction	N/A
N/A	X Walk 1 Width (in)	N/A	N/A	X Walk 2 Width (in)	N/A
	X Walk 1 Slope (%)	1.5		X Walk 2 Slope (%)	N/A
	X Walk 1 X Slope (%)	2.9		X Walk 2 X Slope (%)	N/A

Possible Solutions:

Remove & Replace Entire Ramp.

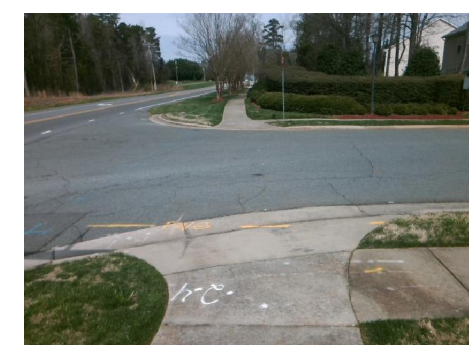
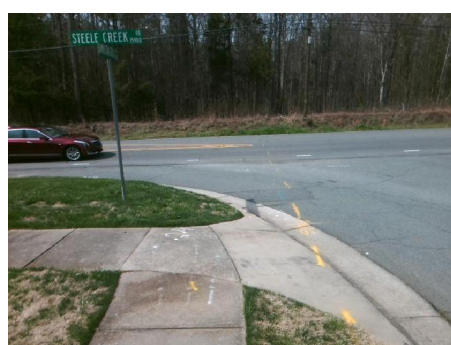
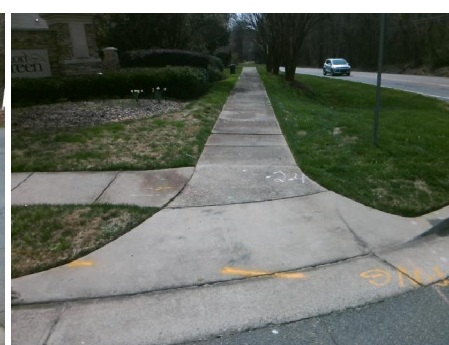
N/A	Ramp inside XWalk1?	N/A	N/A	Ramp inside XWalk2?	N/A
	Road Slope (%)	N/A	N/A	Clear Space?	N/A
	Road X Slope (%)	N/A	N/A	Clear Space to XWalk (in)	N/A
N/A	Any Obstructions?	N/A	N/A	Storm Grate/Utility Hazard?	N/A
	Obstruction Type			Storm Grate/Utility Type	
		N/A			N/A
			Yes	Surface Condition? (G/P)	Good
