# Access Compliance Report

## Public Rights-of-Way

### (Curb Ramps)

Intersection ID: 5585	Main Street: MCCULLOUGH_DR	Cross Street: N/A	Location: S
ADA ID: DE247B2EC151	Ramp Type: PerpDiag	Initial Pass/Fail: Fail	Overall Compliance: No
Codes/Mitigation Info/Possible Solution			Severity Score: 30
			Field Measurements/Component Compliance

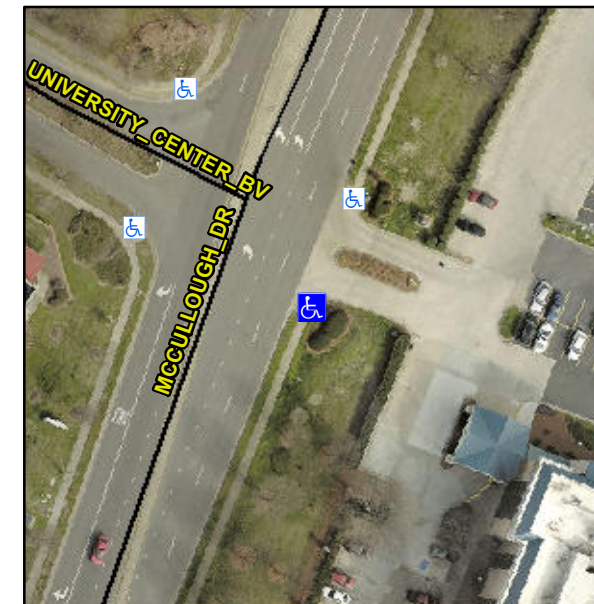
**Not Found, R304.5.1, R304.2.2**

Compliance	Description	Data	Compliance	Description	Data
N/A	Ramp Length (in)	73.0	No	Ramp Slope (%)	9.4
No	Ramp Width (in)	35.5	Yes	Ramp XSlope (%)	1.4
N/A	Flare Type LT	N/A	N/A	Flare Type RT	N/A
N/A	Flare Slope LT (%)	N/A	N/A	Flare Slope RT (%)	N/A
N/A	Flare Traversable LT?	N/A	N/A	Flare Traversable RT?	N/A
N/A	Landing Length (in)	N/A	N/A	DWS Provided?	N/A
N/A	Landing Width (in)	N/A	N/A	DWS Contrast?	N/A
N/A	Landing Slope (%)	N/A	N/A	DWS Length (in)	N/A
N/A	Landing X Slope (%)	N/A	N/A	DWS Full Width?	N/A
N/A	Landing Curb? (Y/N)	N/A	N/A	DWS Offset (in)	N/A
N/A	Shared Landing?	N/A			
N/A	Gutter Ponding?	N/A	N/A	Gutter Slope (%)	N/A
N/A	Gutter Lip Ht (in)	N/A	N/A	Gutter X Slope (%)	N/A
N/A	Painted X Walk1?	No	N/A	Painted X Walk2?	No
	X Walk 1 Direction	To NE		X Walk 2 Direction	To NW
N/A	X Walk 1 Width (in)	N/A	N/A	X Walk 2 Width (in)	N/A
	X Walk 1 Slope (%)	5.0		X Walk 2 Slope (%)	4.0
	X Walk 1 X Slope (%)	3.4		X Walk 2 X Slope (%)	4.2

N/A	Ramp inside XWalk1?	N/A	N/A	Ramp inside XWalk2?	N/A
	Road Slope (%)	0.2	N/A	Clear Space?	N/A
	Road X Slope (%)	6.4	N/A	Clear Space to XWalk (in)	N/A
N/A	Any Obstructions?	N/A	N/A	Storm Grate/Utility Hazard?	N/A
	Obstruction Type			Storm Grate/Utility Type	
		N/A			N/A
			Yes	Surface Condition? (G/P)	Good

**Remove & Replace Curb Ramp With Two New Directional Ramps or Equivalent.**

Total Cost: \$ 3200.00
