# Access Compliance Report

## Public Rights-of-Way

### (Curb Ramps)

Intersection ID: 14504	Main Street: E_7TH_ST	Cross Street: CAMERON_AV	Location: SW
ADA ID: DE26F9669015	Ramp Type: PerpDiag	Initial Pass/Fail: Fail	Overall Compliance: No
Codes/Mitigation Info/Possible Solution		Field Measurements/Component Compliance

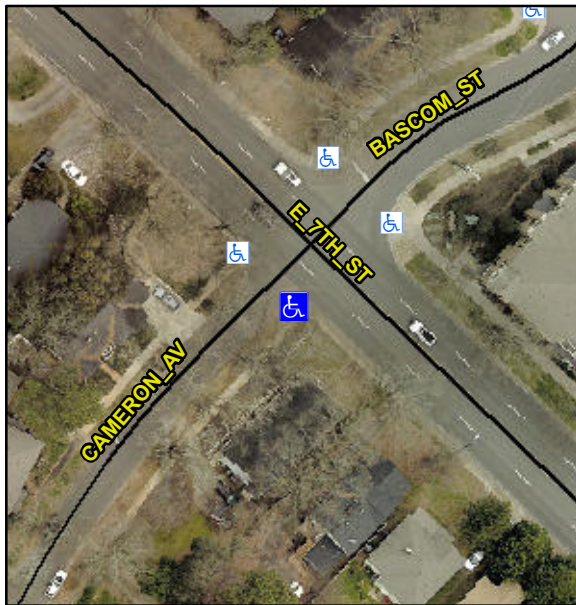
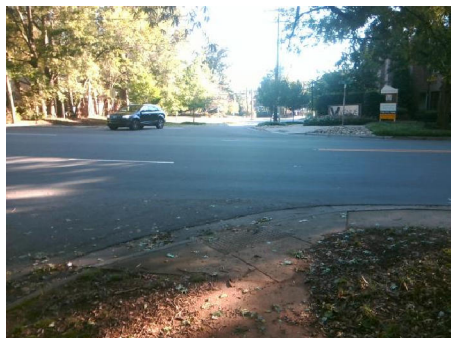
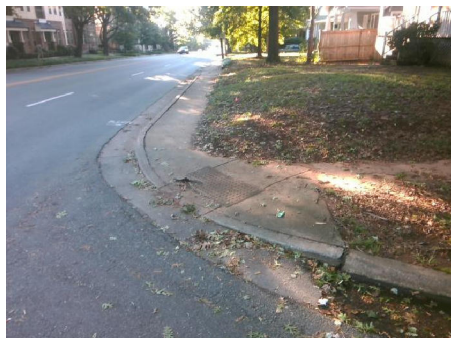
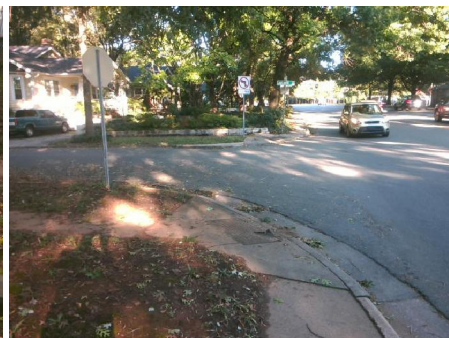
**Not Found, R304.5.1, R304.2.2**

Compliance	Description	Data	Compliance	Description	Data
N/A	Ramp Length (in)	69.0	No	Ramp Slope (%)	8.6
No	Ramp Width (in)	40.5	Yes	Ramp XSlope (%)	0.7
N/A	Flare Type LT	N/A	N/A	Flare Type RT	N/A
N/A	Flare Slope LT (%)	N/A	N/A	Flare Slope RT (%)	N/A
N/A	Flare Traversable LT?	N/A	N/A	Flare Traversable RT?	N/A
N/A	Landing Length (in)	N/A	N/A	DWS Provided?	N/A
N/A	Landing Width (in)	N/A	N/A	DWS Contrast?	N/A
N/A	Landing Slope (%)	N/A	N/A	DWS Length (in)	N/A
N/A	Landing X Slope (%)	N/A	N/A	DWS Full Width?	N/A
N/A	Landing Curb? (Y/N)	N/A	N/A	DWS Offset (in)	N/A
N/A	Shared Landing?	N/A			
N/A	Gutter Ponding?	N/A	N/A	Gutter Slope (%)	N/A
N/A	Gutter Lip Ht (in)	N/A	N/A	Gutter X Slope (%)	N/A
N/A	Painted X Walk1?	No	N/A	Painted X Walk2?	No
	X Walk 1 Direction	To NE		X Walk 2 Direction	To NW
N/A	X Walk 1 Width (in)	N/A	N/A	X Walk 2 Width (in)	N/A
	X Walk 1 Slope (%)	4.8		X Walk 2 Slope (%)	3.1
	X Walk 1 X Slope (%)	3.8		X Walk 2 X Slope (%)	3.0

N/A	Ramp inside XWalk1?	N/A	N/A	Ramp inside XWalk2?	N/A
	Road Slope (%)	1.4	N/A	Clear Space?	N/A
	Road X Slope (%)	5.3	N/A	Clear Space to XWalk (in)	N/A
N/A	Any Obstructions?	N/A	N/A	Storm Grate/Utility Hazard?	N/A
	Obstruction Type			Storm Grate/Utility Type	
		N/A			N/A
			Yes	Surface Condition? (G/P)	Good

**Remove & Replace Curb Ramp With Two New Directional Ramps or Equivalent.**
