Access Compliance Report

Public Rights-of-Way

(Curb Ramps)

Intersection ID: 11455	Main Street: CARLYLE_DR	Cross Street: HEYWOOD_AV	Location: S
ADA ID: DE312C30E957	Ramp Type: Perp	Initial Pass/Fail: Fail	Overall Compliance: No
		Severity Score: 12.5

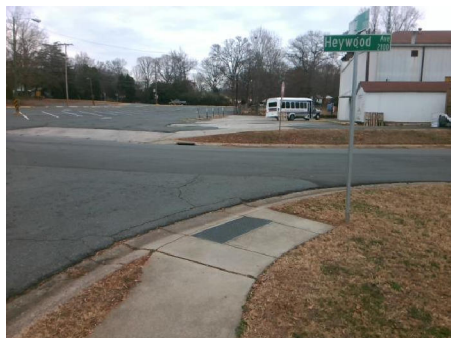
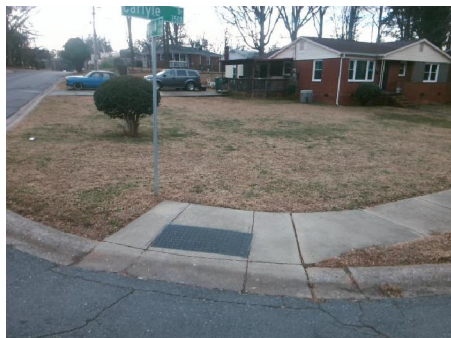
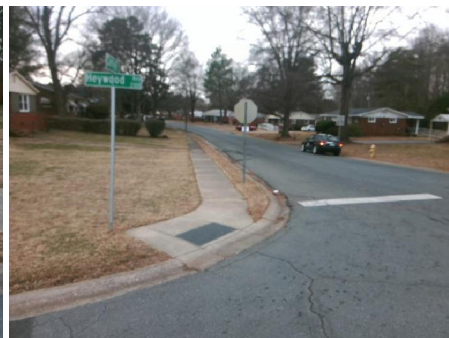
<p>Street 1 Name: HEYWOOD AV</p> <p>Stop Condition-Street 2: StopSign</p> <p>Street 2 Name: N/A</p> <p>Stop Condition-Street 1: N/A</p>	Possible Solutions:		Compliance	Description	Data
	Remove & Replace Entire Ramp.		N/A	Ramp Length (in)	28.0
			Yes	Ramp Width (in)	49.0
			N/A	Flare Type LT	N/A
			N/A	Flare Slope LT (%)	N/A
			N/A	Flare Traversable LT?	N/A
			N/A	Landing Length (in)	N/A
			N/A	Landing Width (in)	N/A
			N/A	Landing Slope (%)	N/A
			N/A	Landing X Slope (%)	N/A
			N/A	Landing Curb? (Y/N)	N/A
			N/A	Shared Landing?	N/A
			N/A	Gutter Ponding?	N/A
			N/A	Gutter Lip Ht (in)	N/A
			N/A	Painted X Walk1?	No
				X Walk 1 Direction	To E
			N/A	X Walk 1 Width (in)	N/A
				X Walk 1 Slope (%)	3.3
				X Walk 1 X Slope (%)	0.9
			N/A	Ramp inside XWalk1?	N/A
<p>Surveyor Notes:</p> <p>N/A</p> <p>PROW/ADA:</p> <p>Not Found, R304.2.2</p> <p>Total Cost: \$ 1850.00</p>			N/A	Flare Type RT	N/A

N/A	Flare Slope RT (%)	N/A
			N/A	Flare Traversable RT?	N/A
			N/A	DWS Provided?	N/A
			N/A	DWS Contrast?	N/A
			N/A	DWS Length (in)	N/A
			N/A	DWS Full Width?	N/A
			N/A	DWS Offset (in)	N/A
			N/A	Gutter Slope (%)	N/A
			N/A	Gutter X Slope (%)	N/A
			N/A	Painted X Walk2?	N/A
				X Walk 2 Direction	N/A
			N/A	X Walk 2 Width (in)	N/A
				X Walk 2 Slope (%)	N/A
				X Walk 2 X Slope (%)	N/A
			N/A	Ramp inside XWalk2?	N/A
			N/A	Clear Space?	N/A
			N/A	Clear Space to XWalk (in)	N/A
			N/A	Storm Grate/Utility Hazard?	N/A
				Storm Grate/Utility Type	
			N/A		N/A
			Yes	Surface Condition? (G/P)	Good
