Access Compliance Report

Public Rights-of-Way

(Curb Ramps)

Intersection ID: 10036289	Main Street: ROSE_RIDGE_PL	Cross Street: N/A	Location: SW
ADA ID: DE371B71627A	Ramp Type: Perp	Initial Pass/Fail: Fail	Overall Compliance: No
Codes/Mitigation Info/Possible Solution		Field Measurements/Component Compliance	
Severity Score: 25

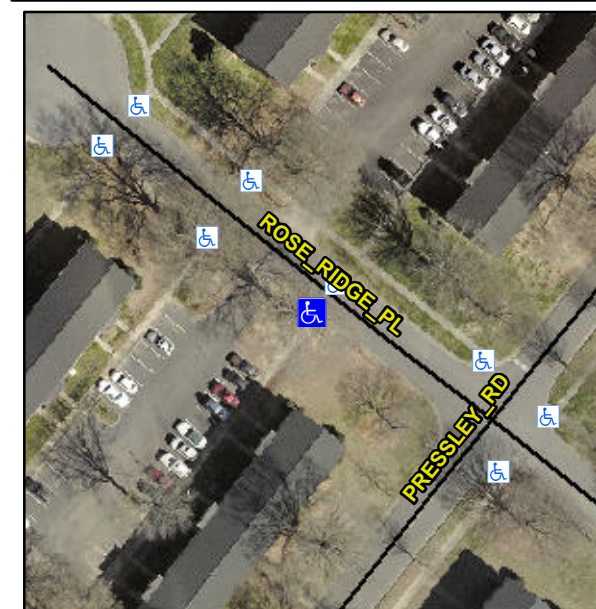
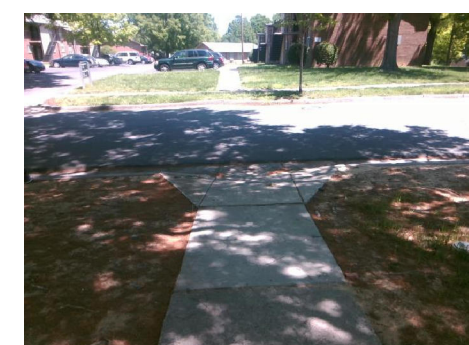
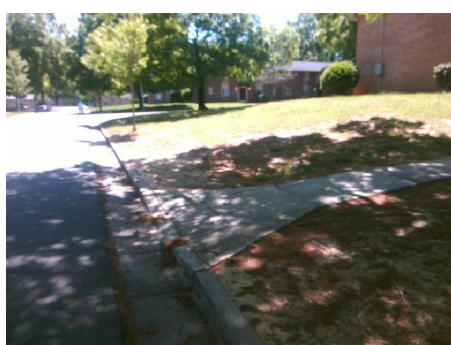
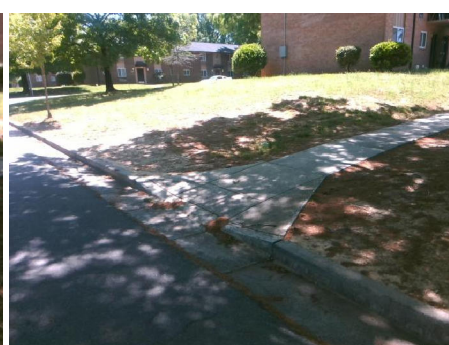
Not Found, R304.2.2

Compliance	Description	Data	Compliance	Description	Data
N/A	Ramp Length (in)	66.0	No	Ramp Slope (%)	17.8
Yes	Ramp Width (in)	48.0	Yes	Ramp XSlope (%)	0.5
N/A	Flare Type LT	N/A	N/A	Flare Type RT	N/A
N/A	Flare Slope LT (%)	N/A	N/A	Flare Slope RT (%)	N/A
N/A	Flare Traversable LT?	N/A	N/A	Flare Traversable RT?	N/A
N/A	Landing Length (in)	N/A	N/A	DWS Provided?	N/A
N/A	Landing Width (in)	N/A	N/A	DWS Contrast?	N/A
N/A	Landing Slope (%)	N/A	N/A	DWS Length (in)	N/A
N/A	Landing X Slope (%)	N/A	N/A	DWS Full Width?	N/A
N/A	Landing Curb? (Y/N)	N/A	N/A	DWS Offset (in)	N/A
N/A	Shared Landing?	N/A			
N/A	Gutter Ponding?	N/A	N/A	Gutter Slope (%)	N/A
N/A	Gutter Lip Ht (in)	1.5	N/A	Gutter X Slope (%)	N/A
N/A	Painted X Walk1?	No	N/A	Painted X Walk2?	N/A
	X Walk 1 Direction	To NE		X Walk 2 Direction	N/A
N/A	X Walk 1 Width (in)	N/A	N/A	X Walk 2 Width (in)	N/A
	X Walk 1 Slope (%)	2.9		X Walk 2 Slope (%)	N/A
	X Walk 1 X Slope (%)	2.6		X Walk 2 X Slope (%)	N/A

Remove & Replace Entire Ramp.
