Access Compliance Report

Public Rights-of-Way

(Curb Ramps)

Intersection ID: 45310	Main Street: BENFIELD_RD	Cross Street: RIDGE_RD	Location: SE
ADA ID: DE3A1E7FC25D	Ramp Type: Perp	Initial Pass/Fail: Fail	Overall Compliance: No
		Severity Score: 12.5

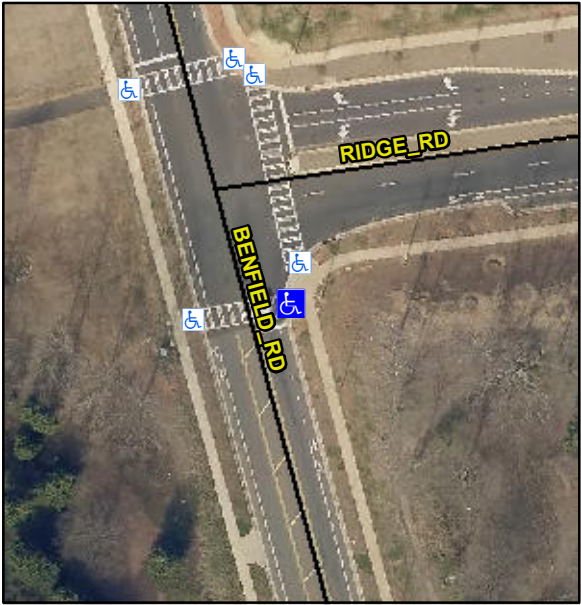
Possible Solutions:		Compliance	Description	Data
	Remove & Replace Entire Ramp.		N/A	Ramp Length (in)	94.0
			Yes	Ramp Width (in)	71.0
			N/A	Flare Type LT	N/A
			N/A	Flare Slope LT (%)	N/A
			N/A	Flare Traversable LT?	N/A
			N/A	Landing Length (in)	N/A
			N/A	Landing Width (in)	N/A
			N/A	Landing Slope (%)	N/A
			N/A	Landing X Slope (%)	N/A
<p>Surveyor Notes:</p> <p>N/A</p> <p>PROW/ADA:</p> <p>R304.2.2</p>			N/A	Flare Type RT	N/A
			N/A	Flare Slope RT (%)	N/A
			N/A	Flare Traversable RT?	N/A
			N/A	DWS Provided?	N/A
			N/A	DWS Contrast?	N/A
			N/A	DWS Length (in)	N/A
			N/A	DWS Full Width?	N/A
			N/A	DWS Offset (in)	N/A
			N/A	Gutter Ponding?	N/A
			N/A	Gutter Lip Ht (in)	N/A
			N/A	Painted X Walk1?	Yes
				X Walk 1 Direction	To W
			N/A	X Walk 1 Width (in)	120.0
				X Walk 1 Slope (%)	3.3
				X Walk 1 X Slope (%)	2.3
			N/A	Ramp inside XWalk1?	Yes

Road Slope (%)	N/A
				Road X Slope (%)	N/A
			N/A	Any Obstructions?	N/A
				Obstruction Type	
Total Cost: \$ 1850.00			N/A	Clear Space?	N/A
				Clear Space to XWalk (in)	N/A
				Storm Grate/Utility Hazard?	N/A
				Storm Grate/Utility Type	
			Yes	Surface Condition? (G/P)	Good
