# Access Compliance Report

## Public Rights-of-Way

| Intersection ID: 18038 | Main Street: INWOOD_DR | Cross Street: MURRAYHILL_RD | Location: SW |
| ADA ID: DE410CBE939C | Ramp Type: Directional1 | Initial Pass/Fail: Pass | Overall Compliance: No |

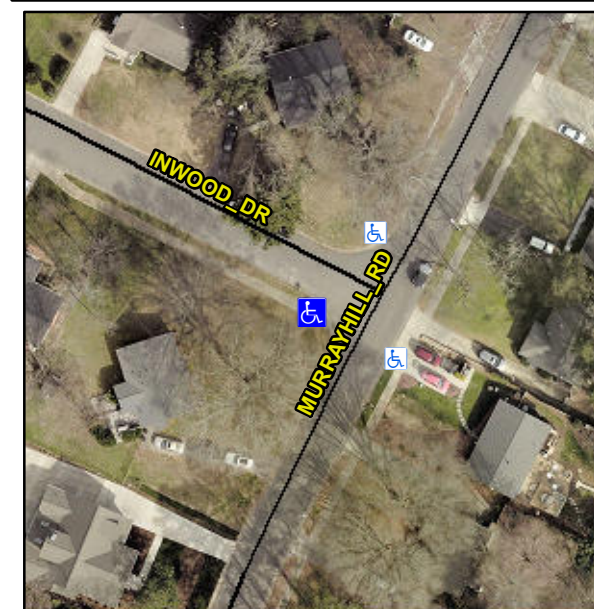
| Severity Score: 17.75 | | | |

| Compliance | Description | Data | Compliance | Description | Data |
|---|---|---|---|---|---|
| No | Ramp XSlope (%) | 2.7 | | | |
| No | Landing Slope (%) | 2.9 | Yes | DWS Length (in) | 24.0 |
| No | Landing X Slope (%) | 2.6 | No | DWS Full Width? | No |
| N/A | Landing Curb? (Y/N) | N/A | No | DWS Offset LT (in) | 85.0 |
| N/A | Shared Landing? | No | No | DWS Offset RT (in) | 27.0 |
| No | Gutter Lip Ht (in) | 1.0 | Yes | Gutter X Slope (%) | 0.2 |

**Remove & Replace Entire Ramp.  
Grind Gutter Lip.**

Total Cost: \$ **1800.00**
