# Access Compliance Report

## Public Rights-of-Way

### (Curb Ramps)

Intersection ID: 10477	Main Street: HAMILTON_ST	Cross Street: POLK_ST	Location: S
ADA ID: DE42E1FB95FE	Ramp Type: BlendTrans1	Initial Pass/Fail: Fail	Overall Compliance: No
			Severity Score: 21.25

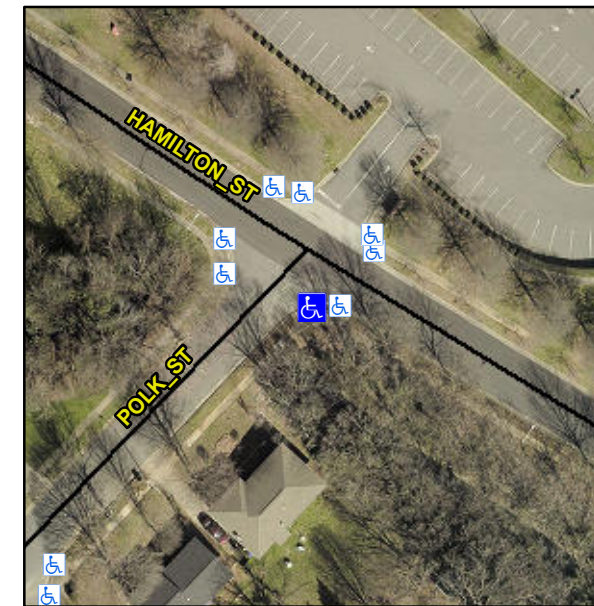
**CURB GAP 2.0**

**Not Found, R304.5.1, R304.5.3**

Compliance	Description	Data	Compliance	Description	Data
N/A	Ramp Length (in)	77.0	Yes	BlendTrans Slope (%)	4.4
No	Ramp Width (in)	46.5	No	BlendTrans XSlope (%)	6.3
N/A	Flare Type LT	N/A	N/A	Flare Type RT	N/A
N/A	Flare Slope LT (%)	N/A	N/A	Flare Slope RT (%)	N/A
N/A	Flare Traversable LT?	N/A	N/A	Flare Traversable RT?	N/A
N/A	Landing Length (in)	N/A	N/A	DWS Provided?	N/A
N/A	Landing Width (in)	N/A	N/A	DWS Contrast?	N/A
N/A	Landing Slope (%)	N/A	N/A	DWS Length (in)	N/A
N/A	Landing X Slope (%)	N/A	N/A	DWS Full Width?	N/A
N/A	Landing Curb? (Y/N)	N/A	N/A	DWS Offset (in)	N/A
N/A	Shared Landing?	N/A			
N/A	Gutter Ponding?	N/A	N/A	Gutter Slope (%)	N/A
N/A	Gutter Lip Ht (in)	N/A	N/A	Gutter X Slope (%)	N/A
N/A	Painted X Walk1?	No	N/A	Painted X Walk2?	N/A
	X Walk 1 Direction	To NW		X Walk 2 Direction	N/A
	X Walk 1 Width (in)	N/A		X Walk 2 Width (in)	N/A
	X Walk 1 Slope (%)	1.6		X Walk 2 Slope (%)	N/A
	X Walk 1 X Slope (%)	2.3		X Walk 2 X Slope (%)	N/A

N/A	Ramp inside XWalk1?	N/A	N/A	Ramp inside XWalk2?	N/A
	Road Slope (%)	2.3		Clear Space?	N/A
	Road X Slope (%)	1.6	N/A	Clear Space to XWalk (in)	N/A
N/A	Any Obstructions?	N/A	N/A	Storm Grate/Utility Hazard?	N/A
	Obstruction Type			Storm Grate/Utility Type	
		N/A			N/A
			Yes	Surface Condition? (G/P)	Good
			No	Curb Slope (%)	12.4

**Remove & Replace Curb Ramp With Two New Directional Ramps or Equivalent.**
