Access Compliance Report

Public Rights-of-Way

(Curb Ramps)

Intersection ID: 28277	Main Street: EASTON_GREY_LN	Cross Street: PEMSWOOD_ST	Location: S
ADA ID: DE611BEC89A4	Ramp Type: Perp	Initial Pass/Fail: Fail	Overall Compliance: No
Severity Score: 12.5			
Codes/Mitigation Info/Possible Solution		Field Measurements/Component Compliance

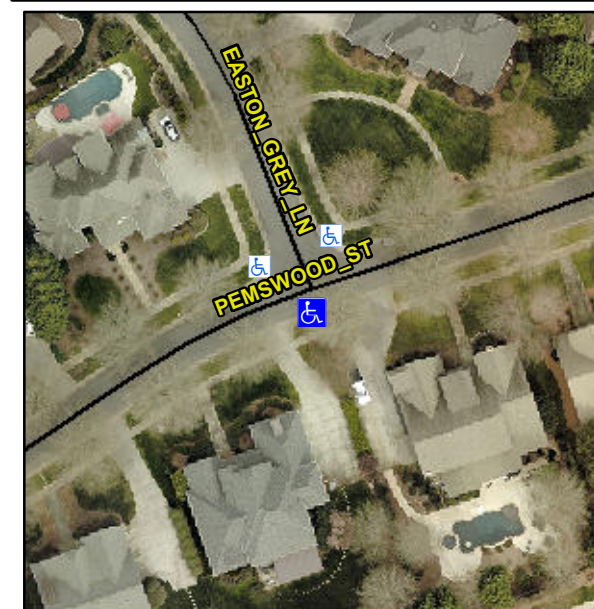
Not Found, R304.2.2

Compliance	Description	Data	Compliance	Description	Data
N/A	Ramp Length (in)	95.0	No	Ramp Slope (%)	9.7
Yes	Ramp Width (in)	59.0	Yes	Ramp XSlope (%)	1.6
N/A	Flare Type LT	N/A	N/A	Flare Type RT	N/A
N/A	Flare Slope LT (%)	N/A	N/A	Flare Slope RT (%)	N/A
N/A	Flare Traversable LT?	N/A	N/A	Flare Traversable RT?	N/A
N/A	Landing Length (in)	N/A	N/A	DWS Provided?	N/A
N/A	Landing Width (in)	N/A	N/A	DWS Contrast?	N/A
N/A	Landing Slope (%)	N/A	N/A	DWS Length (in)	N/A
N/A	Landing X Slope (%)	N/A	N/A	DWS Full Width?	N/A
N/A	Landing Curb? (Y/N)	N/A	N/A	DWS Offset (in)	N/A
N/A	Shared Landing?	N/A			
N/A	Gutter Ponding?	Yes	N/A	Gutter Slope (%)	N/A
N/A	Gutter Lip Ht (in)	N/A	N/A	Gutter X Slope (%)	N/A
N/A	Painted X Walk1?	No	N/A	Painted X Walk2?	N/A
	X Walk 1 Direction	To NW		X Walk 2 Direction	N/A
N/A	X Walk 1 Width (in)	N/A	N/A	X Walk 2 Width (in)	N/A
	X Walk 1 Slope (%)	5.7		X Walk 2 Slope (%)	N/A
	X Walk 1 X Slope (%)	0.4		X Walk 2 X Slope (%)	N/A

N/A	Ramp inside XWalk1?	N/A	N/A	Ramp inside XWalk2?	N/A
	Road Slope (%)	N/A	N/A	Clear Space?	N/A
	Road X Slope (%)	N/A	N/A	Clear Space to XWalk (in)	N/A
N/A	Any Obstructions?	N/A	N/A	Storm Grate/Utility Hazard?	N/A
	Obstruction Type			Storm Grate/Utility Type	
		N/A			N/A
		Yes		Surface Condition? (G/P)	Good

Remove & Replace Entire Ramp.

Total Cost: \$ 1850.00
