Access Compliance Report

Public Rights-of-Way

(Curb Ramps)

| Intersection ID: 8620 | Main Street: DUPREE_ST | Cross Street: HONEYWOOD_AV | Location: | N |

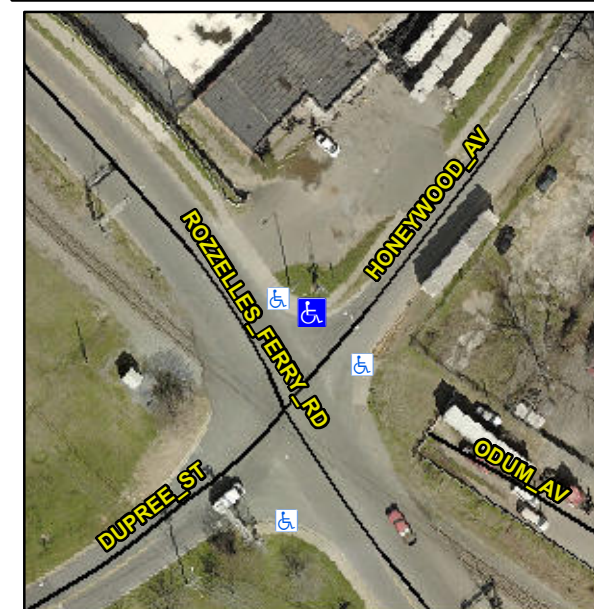
| ADA ID: DE63B3213CA8 | Ramp Type: Perp | Initial Pass/Fail: Fail | Overall Compliance: No | Severity Score: 21.25 |

Not Found, R304.5.1, R304.5.3

| Compliance | Description | Data | Compliance | Description | Data |
|---|---|---|---|---|---|
| N/A | Ramp Length (in) | 78.0 | Yes | Ramp Slope (%) | 6.5 |
| No | Ramp Width (in) | 43.0 | No | Ramp XSlope (%) | 5.1 |

Possible Solutions:

Remove & Replace Entire Ramp.
