Access Compliance Report

Public Rights-of-Way

(Curb Ramps)

Intersection ID: 44836	Main Street: PARKDALE_DR	Cross Street: THRIFTWOOD_DR	Location: S
ADA ID: DE6955B2AB6D	Ramp Type: Perp	Initial Pass/Fail: Fail	Overall Compliance: No
		Severity Score: 12.5

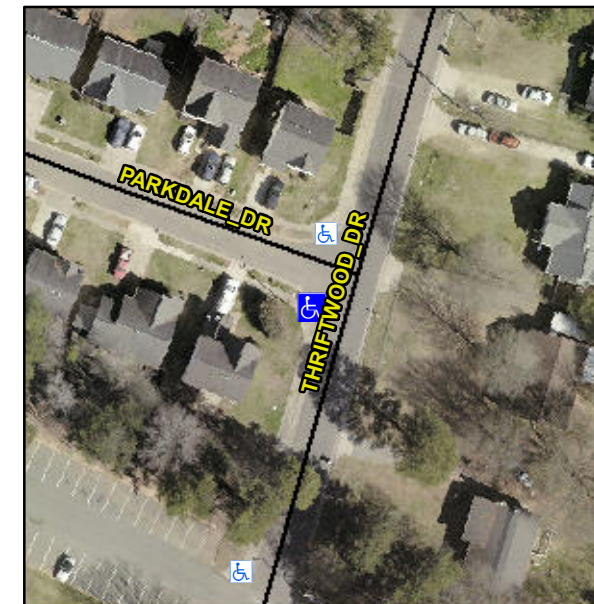
Not Found, R304.5.3

Compliance	Description	Data	Compliance	Description	Data
N/A	Ramp Length (in)	50.0	Yes	Ramp Slope (%)	7.2
Yes	Ramp Width (in)	50.0	No	Ramp XSlope (%)	5.4
N/A	Flare Type LT	N/A	N/A	Flare Type RT	N/A
N/A	Flare Slope LT (%)	N/A	N/A	Flare Slope RT (%)	N/A
N/A	Flare Traversable LT?	N/A	N/A	Flare Traversable RT?	N/A
N/A	Landing Length (in)	N/A	N/A	DWS Provided?	N/A
N/A	Landing Width (in)	N/A	N/A	DWS Contrast?	N/A
N/A	Landing Slope (%)	N/A	N/A	DWS Length (in)	N/A
N/A	Landing X Slope (%)	N/A	N/A	DWS Full Width?	N/A
N/A	Landing Curb? (Y/N)	N/A	N/A	DWS Offset (in)	N/A
N/A	Shared Landing?	N/A			
N/A	Gutter Ponding?	N/A	N/A	Gutter Slope (%)	N/A
N/A	Gutter Lip Ht (in)	0.5	N/A	Gutter X Slope (%)	N/A
N/A	Painted X Walk1?	No	N/A	Painted X Walk2?	N/A
	X Walk 1 Direction	To NE		X Walk 2 Direction	N/A
N/A	X Walk 1 Width (in)	N/A	N/A	X Walk 2 Width (in)	N/A
	X Walk 1 Slope (%)	5.2		X Walk 2 Slope (%)	N/A
	X Walk 1 X Slope (%)	1.0		X Walk 2 X Slope (%)	N/A

N/A	Ramp inside XWalk1?	N/A	N/A	Ramp inside XWalk2?	N/A
	Road Slope (%)	N/A	N/A	Clear Space?	N/A
	Road X Slope (%)	N/A	N/A	Clear Space to XWalk (in)	N/A
N/A	Any Obstructions?	N/A	N/A	Storm Grate/Utility Hazard?	N/A
	Obstruction Type			Storm Grate/Utility Type	
		N/A			N/A
			Yes	Surface Condition? (G/P)	Good

Remove & Replace Entire Ramp.

Total Cost: \$ 1850.00
