# Access Compliance Report

## Public Rights-of-Way

Intersection ID: 50494	Main Street: BLAIREBETH_ST	Cross Street: HAWFIELD_WAY_DR	Location: SW
ADA ID: DE6CD2778A1A	Ramp Type: PerpDiag	Initial Pass/Fail: Fail	Overall Compliance: No
		Severity Score: 1.25

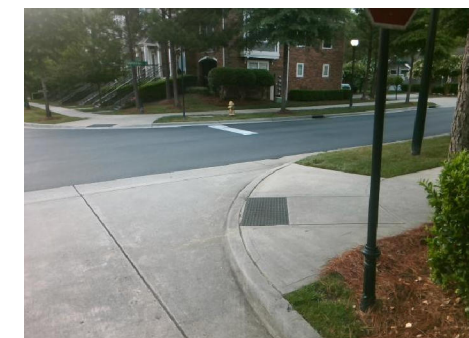
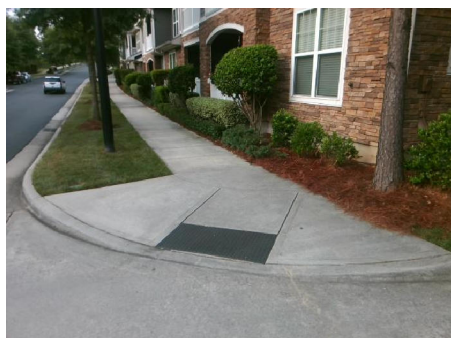
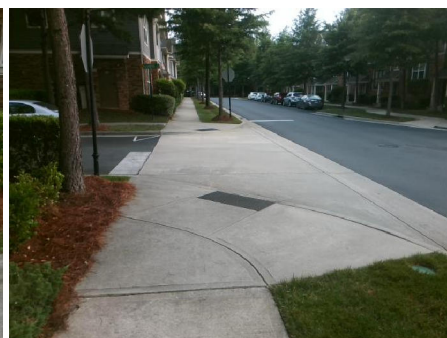
Compliance	Description	Data	Compliance	Description	Data
N/A	Ramp Length (in)	79.0	Yes	Ramp Slope (%)	5.5
Yes	Ramp Width (in)	48.0	No	Ramp XSlope (%)	4.5
N/A	Flare Type LT	N/A	N/A	Flare Type RT	N/A
N/A	Flare Slope LT (%)	N/A	N/A	Flare Slope RT (%)	N/A
N/A	Flare Traversable LT?	N/A	N/A	Flare Traversable RT?	N/A
N/A	Landing Length (in)	N/A	N/A	DWS Provided?	N/A
N/A	Landing Width (in)	N/A	N/A	DWS Contrast?	N/A
N/A	Landing Slope (%)	N/A	N/A	DWS Length (in)	N/A
N/A	Landing X Slope (%)	N/A	N/A	DWS Full Width?	N/A
N/A	Landing Curb? (Y/N)	N/A	N/A	DWS Offset (in)	N/A
N/A	Shared Landing?	N/A			
N/A	Gutter Ponding?	N/A	N/A	Gutter Slope (%)	N/A
N/A	Gutter Lip Ht (in)	N/A	N/A	Gutter X Slope (%)	N/A
N/A	Painted X Walk1?	No	N/A	Painted X Walk2?	No
	X Walk 1 Direction	To NE		X Walk 2 Direction	To NW
N/A	X Walk 1 Width (in)	N/A	N/A	X Walk 2 Width (in)	N/A
	X Walk 1 Slope (%)	2.6		X Walk 2 Slope (%)	1.5
	X Walk 1 X Slope (%)	0.9		X Walk 2 X Slope (%)	2.3

N/A	Ramp inside XWalk1?	N/A	N/A	Ramp inside XWalk2?	N/A
	Road Slope (%)	1.5	N/A	Clear Space?	N/A
	Road X Slope (%)	0.3	N/A	Clear Space to XWalk (in)	N/A
N/A	Any Obstructions?	N/A	N/A	Storm Grate/Utility Hazard?	N/A
	Obstruction Type			Storm Grate/Utility Type	
		N/A			N/A
			Yes	Surface Condition? (G/P)	Good

**Remove & Replace Curb Ramp With Two New Directional Ramps or Equivalent.**

**R304.5.3**
