Access Compliance Report

Public Rights-of-Way

(Curb Ramps)

Intersection ID: 44754	Main Street: LENOX_POINTE_DR	Cross Street: PIONEER_AV	Location: NW
ADA ID: DE719D25A235	Ramp Type: PerpDiag	Initial Pass/Fail: Fail	Overall Compliance: No
		Severity Score: 25

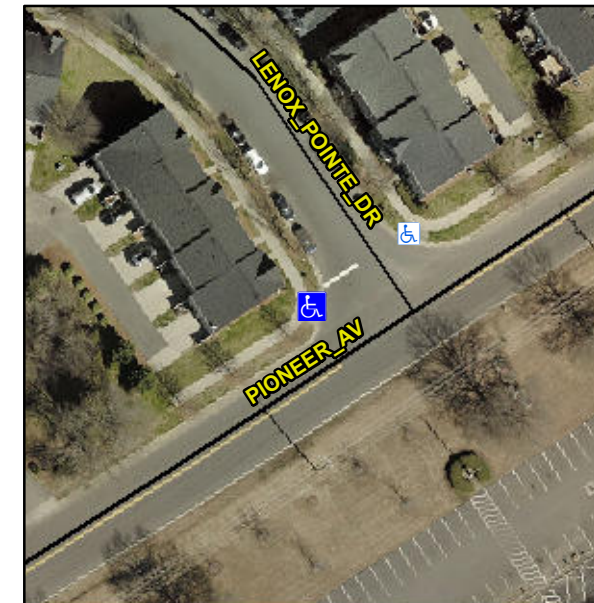
Not Found, R304.2.2

Compliance	Description	Data	Compliance	Description	Data
N/A	Ramp Length (in)	73.0	No	Ramp Slope (%)	12.1
Yes	Ramp Width (in)	48.0	Yes	Ramp XSlope (%)	0.0
N/A	Flare Type LT	N/A	N/A	Flare Type RT	N/A
N/A	Flare Slope LT (%)	N/A	N/A	Flare Slope RT (%)	N/A
N/A	Flare Traversable LT?	N/A	N/A	Flare Traversable RT?	N/A
N/A	Landing Length (in)	N/A	N/A	DWS Provided?	N/A
N/A	Landing Width (in)	N/A	N/A	DWS Contrast?	N/A
N/A	Landing Slope (%)	N/A	N/A	DWS Length (in)	N/A
N/A	Landing X Slope (%)	N/A	N/A	DWS Full Width?	N/A
N/A	Landing Curb? (Y/N)	N/A	N/A	DWS Offset (in)	N/A
N/A	Shared Landing?	N/A			
N/A	Gutter Ponding?	N/A	N/A	Gutter Slope (%)	N/A
N/A	Gutter Lip Ht (in)	N/A	N/A	Gutter X Slope (%)	N/A
N/A	Painted X Walk1?	No	N/A	Painted X Walk2?	No
	X Walk 1 Direction	To SE		X Walk 2 Direction	To NE
N/A	X Walk 1 Width (in)	N/A	N/A	X Walk 2 Width (in)	N/A
	X Walk 1 Slope (%)	5.0		X Walk 2 Slope (%)	0.3
	X Walk 1 X Slope (%)	0.5		X Walk 2 X Slope (%)	5.1

N/A	Ramp inside XWalk1?	N/A	N/A	Ramp inside XWalk2?	N/A
	Road Slope (%)	3.2	N/A	Clear Space?	N/A
	Road X Slope (%)	3.0	N/A	Clear Space to XWalk (in)	N/A
N/A	Any Obstructions?	N/A	N/A	Storm Grate/Utility Hazard?	N/A
	Obstruction Type			Storm Grate/Utility Type	
		N/A			N/A
			Yes	Surface Condition? (G/P)	Good

Remove & Replace Curb Ramp With Two New Directional Ramps or Equivalent.
